SERVICE INFORMATION Bulletin Nbr: 363-2027 Date:.....SEPTEMBER 1998 Market: US, CA

Nuts on rear window and windshield wiper arms come loose

Saab 900/9-3 (3D/5D) M94-

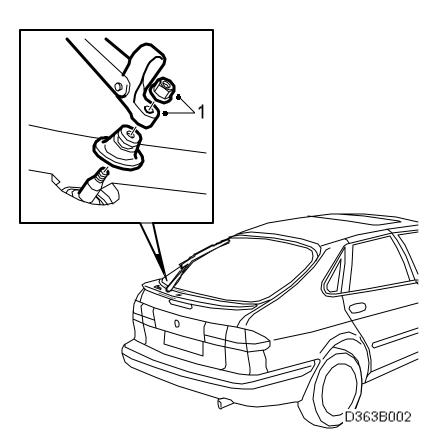
Rear window wiper arm

The nut (M6) securing the rear window wiper on the cars concerned may come loose, preventing the rear window wiper from functioning satisfactorily.

- 1. Lift the protective cover and undo the nut.
- 2. If the wiper arm comes loose from the lead through, align the centre of the blade to the edge of the black area on the left-hand side of the window.
- 3. Apply a few drops of Loctite 242, part no. (16) 74 96 268, to the thread in the nut and fit the nut.

Tightening torque: 8.5 Nm (6.2 lbf ft)

4. Check the function.

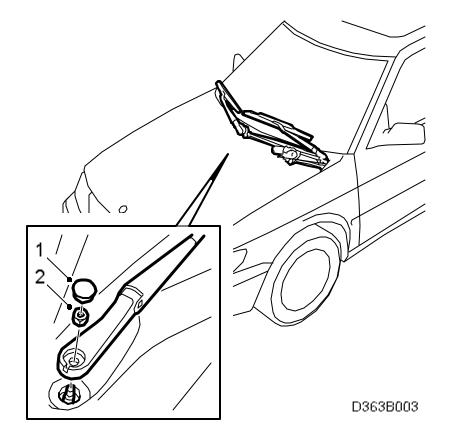
Windshield wiper arm

The nuts (M8) securing the windshield wiper arms on the cars concerned may come loose, preventing the windshield wipers from functioning satisfactorily.

- 1. Remove the protective cover with a screwdriver.
- 2. Remove the nut.
- 3. Apply a few drops of Loctite 242, part no. (16) 74 96 268, to the thread in the nut and fit the nut.

Tightening torque: 20 Nm (14.7 lbf ft)

- 4. Fit the protective cover and repeat the procedure on the other wiper arm.
- 5. Check the function.
