## SERVICE INSTRUCTION

**Number:** 843-1953

### Juddering side windows (unsmooth operation)

Saab 9-5 up to and including VIN

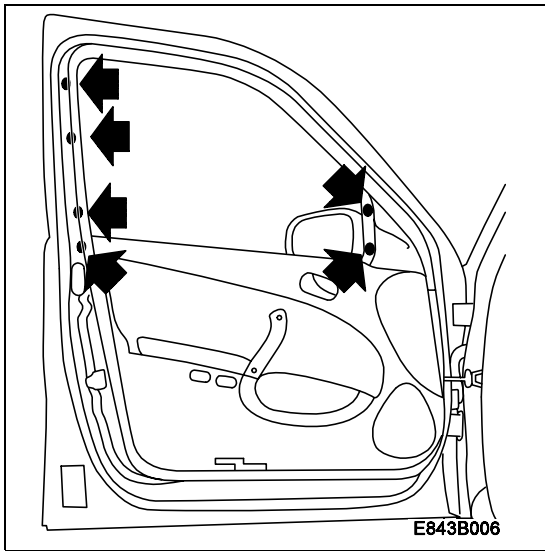
- 1 Clean the glass of any paint protector.
- 2 Lower the side window, insert a blunt object into the weatherstrip and see if any of the pop rivets are protruding.

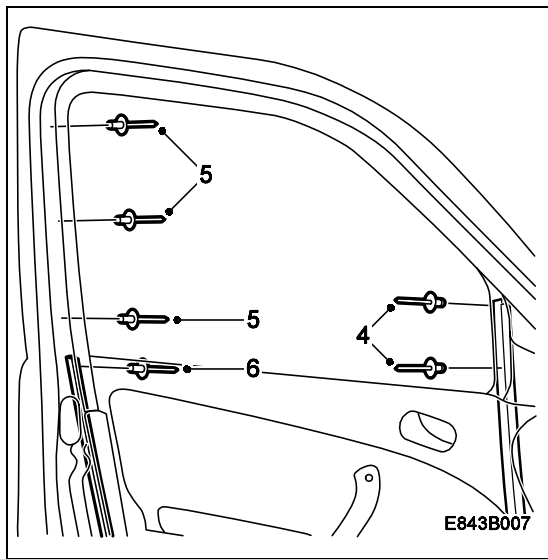
- 4 Inspect the two pop rivets (part no. 79 72 516) at the front edge of the moulding.
- 5 Inspect the three pop rivets (part no. 46 85 632) at the rear edge of the moulding (B pillar).
- 6 Inspect the pop rivet (part no. 79 72 516) at the lower rear edge.
- 7 Drill out any defective pop rivets and fit new ones.
- 8 Clean any drill cuttings from the moulding and refit it.

Check the rivets once more before refitting the moulding.

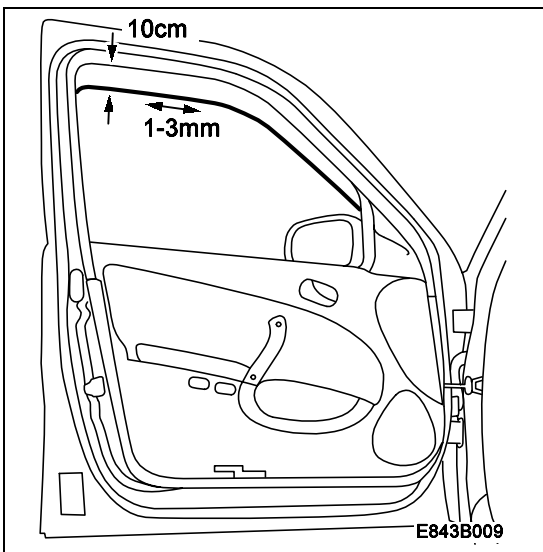
12 Check the window adjustment by lowering it 10 cm and grasping the to edge of the glass. If the window cannot be moved back and forth 1-3 mm, the following adjustment must be made.

13 Remove the door trim and water barrier, see WIS 8, Body, Interior equipment, Door trim.
