**SERVICE INFORMATION**

**Number:** 210-1797

**Correcting Engine Block Pitting**

All models with 4-cylinder engines

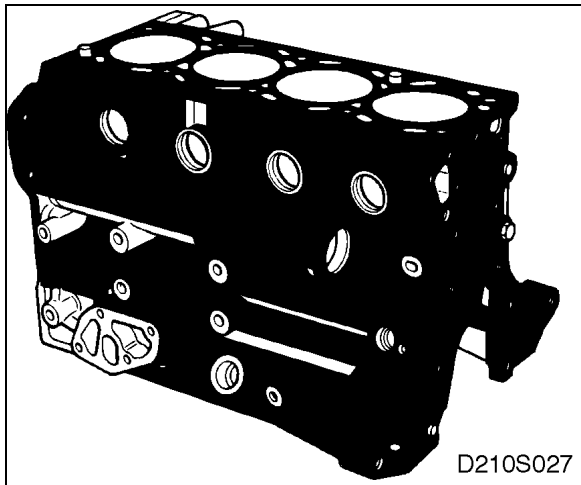
Under certain conditions, the upper engine block surface may become eroded from prolonged leakage of the head gasket.

The erosion appears as a pitting of the block surface around the coolant passages.

The eroded portion of the block surface can be built up using JB Weld or similar machineable epoxy without removing the engine from the vehicle.

- 1 Remove the cylinder head and the gasket.
- 2 Clean the surface and apply the epoxy following the instructions provided with the epoxy. Take great care to apply epoxy evenly, building up the eroded area above the actual deck height.

After the material is fully set-up, sand the area with a sanding block so that the deck surface is even and smooth. Take care not to remove any metal from the deck.
