SERVICE INFORMATION

Number: 232-1734

'O'rings generating drivability problems

Saab 900 M94 onwards with naturally aspirated 4-cylinder engines (B204i/B206i/B234i).

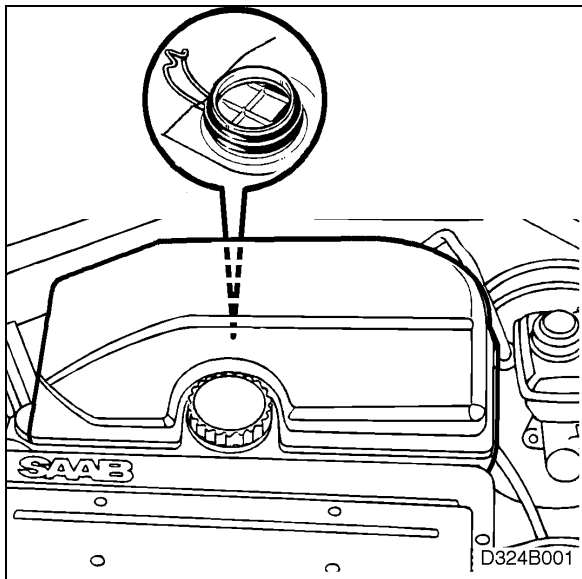
If the 'O' rings between the resonator and the throttle body have been fitted incorrectly so that they are not seated properly, the engine can draw in air that has not passed through the mass air flow sensor. This can give rise to drivability problems with implications for fault diagnosis.

When any work is done that involves removing the resonator from the throttle body, the following steps must always be taken:

- Check the condition of the 'O' rings and that they are properly seated. Replace any that are deformed.
- Grease the 'O' rings with acid-free petroleum jelly.
