**SERVICE INFORMATION**

Bulletin Nbr: 232-1734 UTG. 2

**O-rings may cause problems with driveability**

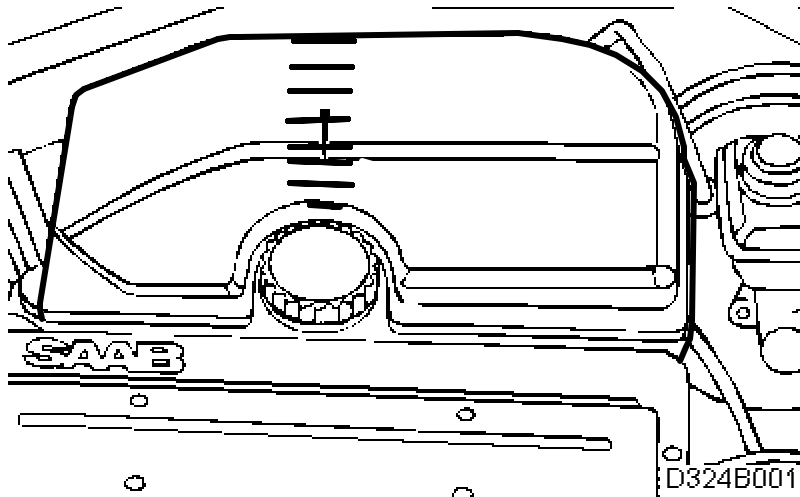
It is possible for the O-rings between the resonator and the throttle body to be fitted incorrectly on assembly causing the engine to take in air that has not passed through the mass air flow sensor. This can result in driveability problems and subsequent fault diagnosis procedures.

The following measures must be taken unconditionally when carrying out work that involves removing the resonator from the throttle body:

- Check O-rings and their locations. Replace deformed O-rings.
- Lubricate O-rings with acid-free vaseline.
