MODIFICATION INSTRUCTION

Bulletin Nbr: 248-2245 Date:....juni 2000

Incorrect position, rear oxygen sensor cable US

Customer satisfaction campaign 118 41

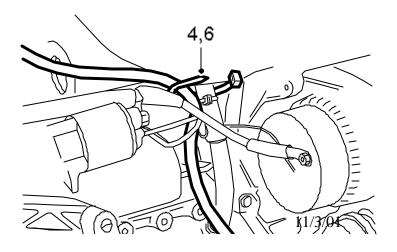
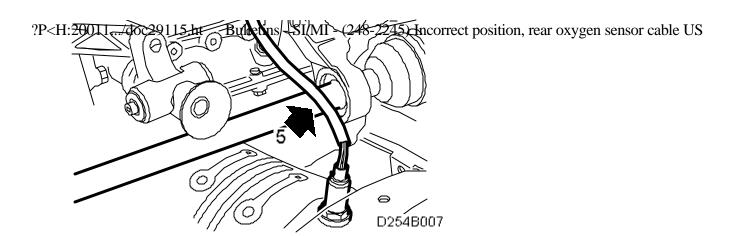
The rear oxygen sensor cable on certain cars may be lying too close to the intermediate shaft, which means that the cable sheath and insulation can be damaged. This is caused by the cable being poorly secured.

Chafed cable

- 1. Check the oxygen sensor cable in the illustrated area
- 2. If only the outer sheath of the oxygen sensor cable is chafed, it will suffice to insulate the damaged area with insulating tape. Continue to step 4.
- 3. If the cable has been damaged down to the insulation then the oxygen sensor must be replaced. See WIS Engine Trionic T7 OBD2 Adjustment/replacement Rear oxygen sensor. Do not forget to secure the cable with the cable tie as described in steps 5-7.
- 4. Cut off the cable tie securing the rear oxygen sensor cable to the oil filler pipe.
- 5. Run the cable so it is not resting against the intermediate shaft. It must not be taut either
- 6. Secure the cable to the oil filler pipe with a new cable tie.
- 7. Cut off the loose end of the cable tie.
