**SERVICE INFORMATION**

**Number:** 291-1098

**Replacement of turbo unit**

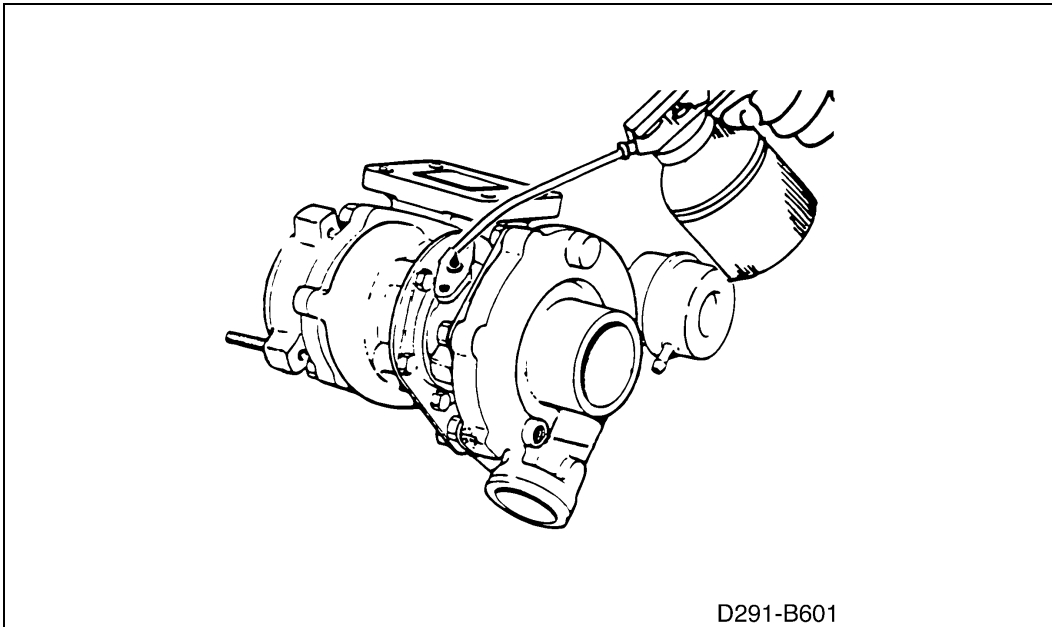
Replacement turbo units can be seriously damaged by inadequate initial lubrication, with the result that they have to be scrapped.

This will ensure that an adequate film of oil will be present between the turbine shaft and bearing during the period it takes for the oil pressure to build up after the engine has been started for the first time following fitting of the replacement unit.

Before fitting a replacement unit, fill the lubricating oil passage with engine oil as shown.
