MODIFICATION INSTRUCTION

Bulletin Nbr: 291-2217 utg. 2

Replacement of check valve and banjo screw to remedy blue smoke

Emissions-related campaign 10719

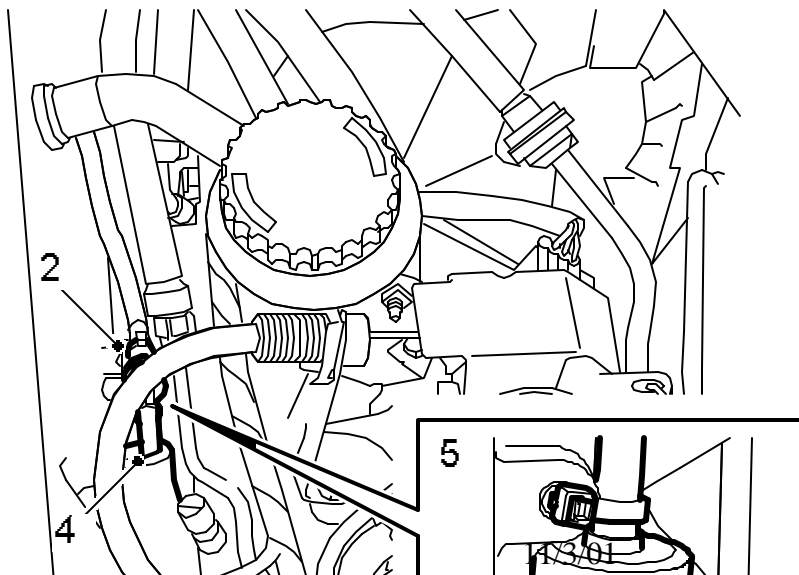
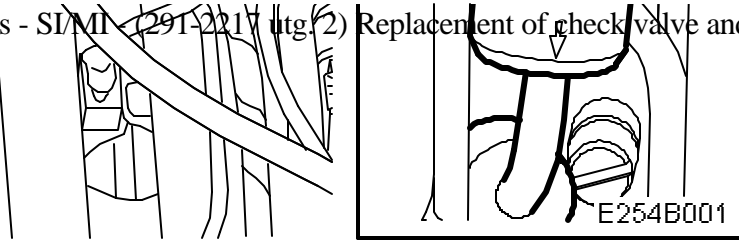
- The check valve for the crankcase ventilation can stick, which means that engine oil can be forced out into the exhaust pipe, resulting in blue smoke.
- The flow of coolant through the turbo unit may be reduced, which results in the temperature becoming so high that the engine oil crystallizes (builds carbon deposits) around the turbine-side bearing. Over time these deposits reduce the oil flow through the bearing, which means that engine oil is forced past the turbine shaft seal and out into the exhaust pipe, resulting in blue smoke.

2. Cut off the cable tie securing the check valve to the camshaft cover.
3. Detach the vacuum hose from the camshaft cover and the throttle body.
4. Transfer the insulation hose from the old hose to the new.
5. Attach the new hose to the camshaft cover nipple and to the throttle body.

The check valve must be turned so that the flow is directed away from the camshaft cover towards the throttle body, see the arrow on the check valve.
