SERVICE INFORMATION

Number: 363-1459

Risk of blocked windscreen washer hose

Saab 900 M94-

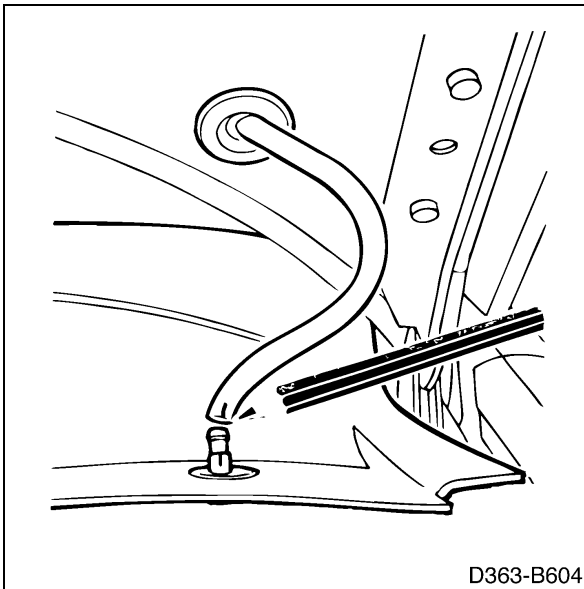
If the washer is removed from the plastic grommet in the cover on the top of the false bulkhead space, it is very important that the washer hose be refitted correctly.

If the washer hose is twisted more than 1/4 turn in relation to its previous orientation, there is a great risk that the hose will become kinked, causing a blockage.

To eliminate the risk of the washer hose becoming blocked the washer hose and the plastic grommet should be marked prior to removal to indicate their relative position.
