**SERVICE INFORMATION**

Number: 371-1602

## Sealing of connectors

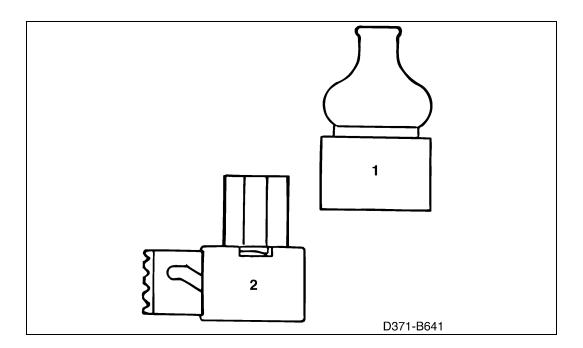
Bosch connectors that are used in the engine bay may in certain cases exhibit corroded cable terminals as a result of moisture penetrating the connector housing.

To prevent the ingress of moisture, a special repair kit containing shrink tubing and adhesive has been developed. This kit can be used for Bosch connectors (1) from 2-pin up to 7-pin (but not for the new type of scat-sealed (2) connectors).

- 1 Unplug the connector from the component.
- 2 Peel back the connector's rubber shroud along the cable.
- 3 Mark the leads and withdraw them from the connector.
- 4 Pull the rubber shroud off the cable.

Inspect the cable terminals for moisture and corrosion. If the cable terminals display the effects of corrosion they must be changed. Otherwise it will suffice to blow them clean and spray them with Kontakt 61 contact cleaner.
