SERVICE INFORMATION
Number:	412-9016
Year:	1995
Month:	SEPTEMBER
Market:	US CA

Correcting a customer complaint regarding clutch pedal play

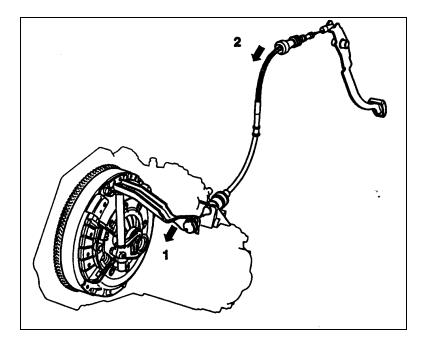
On 1994 and later 900 models equipped with manual transmissions, customers may complain that their car has excessive clutch pedal play or a clutch that engages too early (when the pedal is close to the floor). The following procedure will resolve such a complaint.

- 1 Pull the clutch lever forward 2-3 times (see item 1, figure 1). Listen for squeaking or any other unwanted noise.
- 2 Move the main fuse box out of the way (see item 3, figure 2). This will enable you to easily reach the return spring.

3 Pull the return spring forward, away from the bulkhead (see item 2, figure 1), then release the spring.

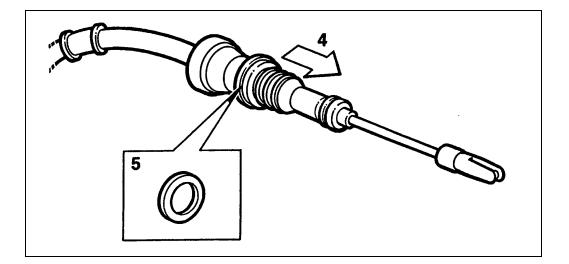
4 Check the free play in the clutch pedal. If it is 20mm or less, no further adjustment is necessary. If pedal free play is greater than 20 mm, perform Action 2.

- 5 If you heard any squeaking or unwanted noise when you pulled the clutch lever forward in step 1 or while working the clutch pedal up and down, apply Moycote to the cable's plastic ring where it touches the clutch pedal.
- 6 Move the main fuse box back in place.
