**SERVICE INFORMATION**

Bulletin Nbr: 440-2220  
 Date:.....Februari 2000  
 Market: US, CA

**Common automatic transmission faults**

Saab 9-3, M98-99 with automatic transmission.

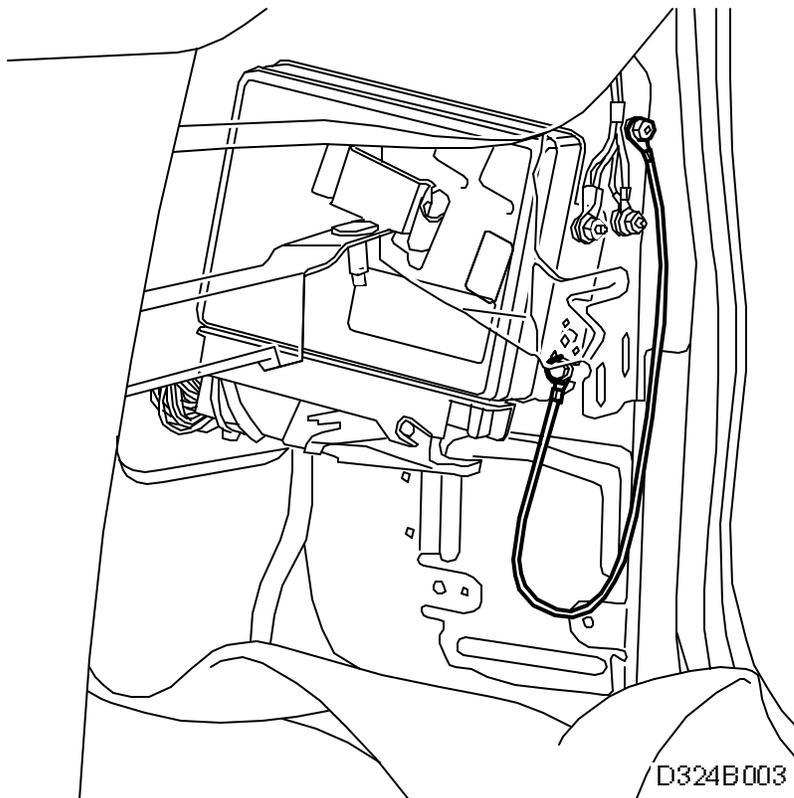
2. DTC P0741 generated, (lock-up function faulty). Only applies to cars with the Motronic engine management system.

**Symptom:** CHECK GEARBOX lamp comes on and transmission goes into "limp-home" mode.

**Cause:** The ignition coil in cars with the Motronic engine management system can produce high voltage surges in the wiring harness. The Motronic control module interprets the voltage surge as changes in the engine speed. The cause of the voltage surges can be insufficient conductivity in the cable, bad grounding of the gearbox to the body or bad grounding of the Motronic control module to the body. Normal fault criteria for the DTCs are that the difference between the engine speed and input speed in the gearbox is greater than 100 rpm for 10 seconds.

2. **DTC P0741**

Check using Tech 2, Read value TCM, if the signal for the idling speed varies between 900 and 1600 rpm, observe the curve on the diagnostic tool display. If there is a variation, improve the grounding to the Motronic control module and gearbox. The control module is grounded to the holder that is attached to the bodywork. The holder is painted, which can be the cause of the bad grounding.

In order to improve the grounding, proceed as follows: Make a ground cable 2.5 mm<sup>2</sup>, approx. 20 cm long. Connect the cable between the nut in the corner of the control module and the A-pillar grounding point G34P, put on a serrated lock washer. See illustration. Clear DTC.

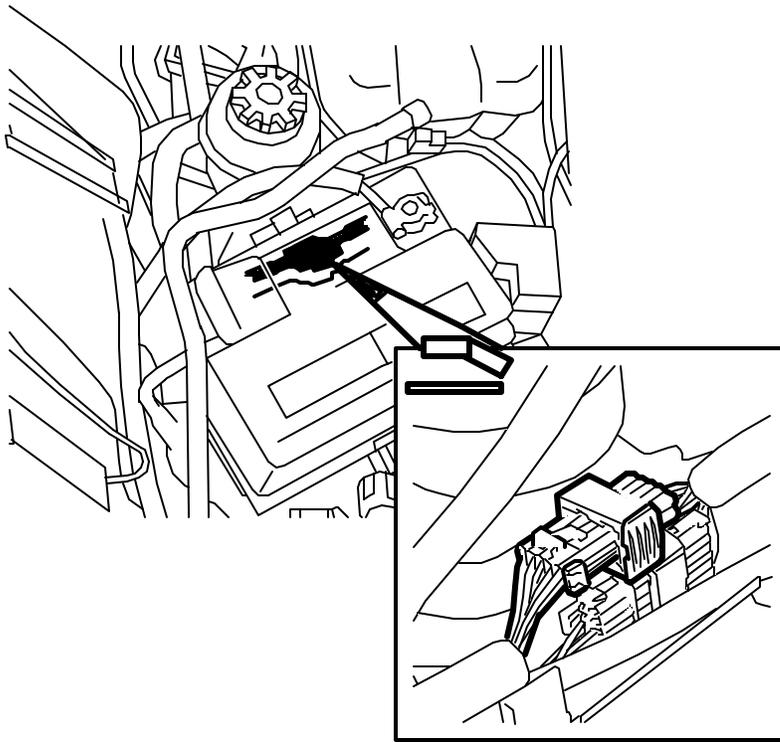
D440B614

3. DTC P0705 generated (Gear selector position sensor, faulty signal).

**Symptom:** CHECK GEARBOX lamp comes on and transmission goes to "limp-home" mode. The fault arises intermittently in extremely cold or extremely hot temperatures.

**Cause:** The transmission control module receives a 12V signal from the four contacts in the gear selector position sensor. At least 2 contacts are active in all gear positions. If the control module does not receive a 12V signal from 2 of the contacts, a DTC will be generated. The DTC is generated if the fault is present for longer than 0.5 seconds. This applies to M98. For M99, the DTC is not generated until after 5 seconds.

3. **DTC P0705**

- The connectors H10-1 and H10-3 are located under the battery tray, which means they are more exposed to corrosion. Clean using electronic cleaning fluid part no. 30 09 461 and then spray with Kontakt 61, part no. 30 04 520.

- Change to a new gear selector position sensor, see WIS, Transmission, Automatic transmission, Adjustment/replacement, Gear selector position sensor.
