**SERVICE INFORMATION**

**Number:** 475-1883

**Noise from outboard drive shaft CV joint**

All Saab 900 models.

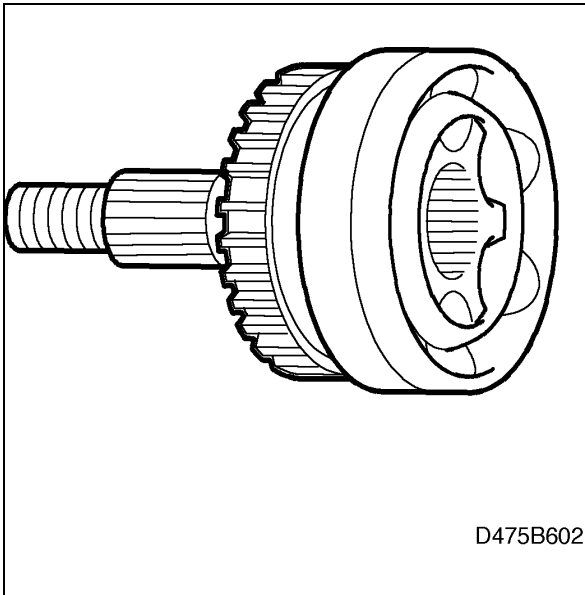
Noise may be heard from the outboard drive shaft CV joints on new cars under certain driving conditions, with the steering wheel at full lock while accelerating at the same time.

This is because the grease in the joints has not had time to be properly distributed.

Inform the customer of the above in the event of a complaint and that the noise will disappear after about 100-150 km (65-100 miles) under normal driving conditions.
