SERVICE INSTRUCTION

Number: 510-1912

Vibration while braking

Saab 9-5 M98-

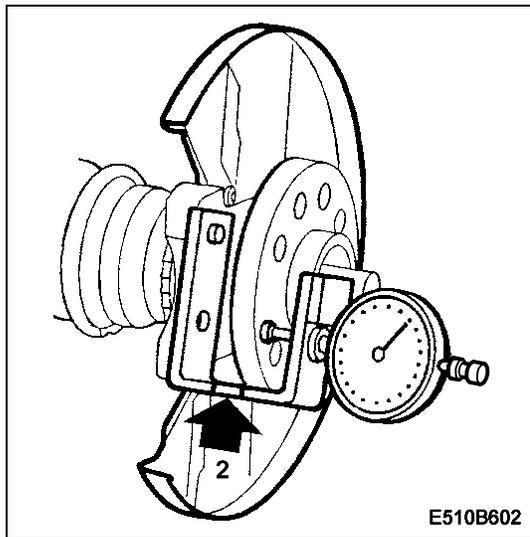
- 1 Remove the wheel, brake caliper and brake disc.
- 2 Make sure the hub is clean and free from impurities. Only one indicator gauge is used. Grind out the tool as illustrated to prevent the wheel hub from making contact with it.
- 3 Rotate the hub and check the run out (the value between the highest and lowest reading).
If the run out exceeds 0.03 mm, the hub must be replaced.

The dial gauge will jump about 0.03-0.05 mm at each wheel bolt hole, which is completely normal.

- 4 Fit the brake disc, brake caliper and wheel.
Tighten the wheel bolts.

Tightening torque 120 Nm (89 lbf ft)
