SERVICE INFORMATION

Bulletin Nbr: 522-2043
Date:.....OCTOBER 1998
Market: US, CA

Proper Brake Fluid Cap Fit

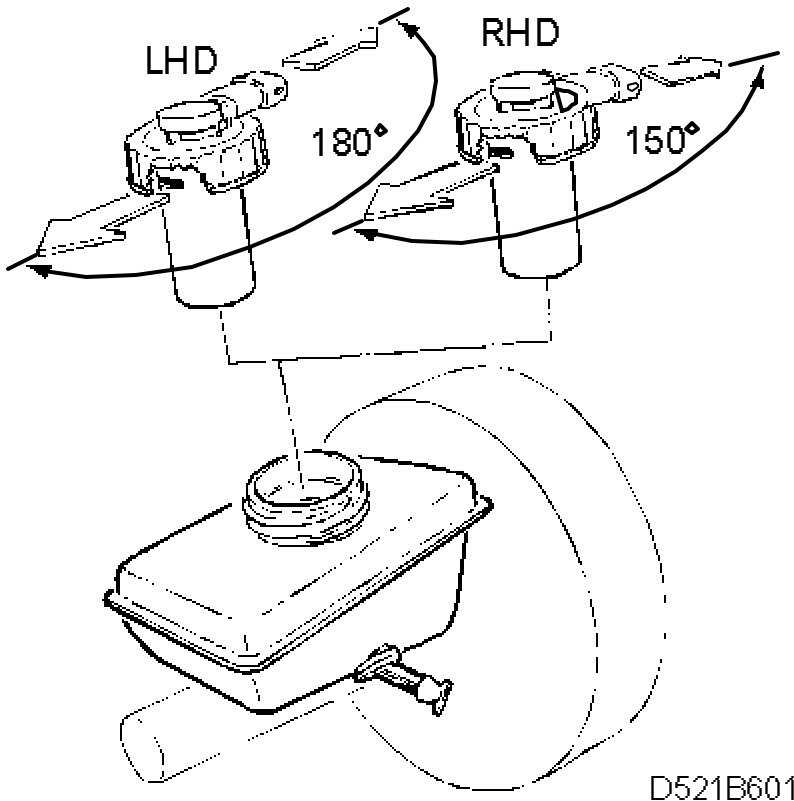
D521B601

Depending on the manner in which the brake fluid reservoir cap has been screwed on, leaks may arise in certain adverse positions. This can be detected by inspecting the engine bay or by the brake fluid warning lamp going on.

This is caused by a non-return valve in the level indicator pipe in the cap acting as a pump when the cap has been fitted incorrectly. Due to this, the fluid cannot drain back into the reservoir. Eventually, the fluid is drained through the vent hole in the cap. This phenomenon is not dependent on the fluid level but can be aggravated by an overfilled reservoir.

1. Unscrew the cap.
2. **LHD:** Turn the level indicator pipe so that the drain hole is 180 to the electrical connection.
RHD: Turn the level indicator pipe so that the drain hole is 150 to the electrical connector.
3. Fit the cap. The drain hole should be turned towards the front.
