SERVICE INFORMATION

Number: 641-1512 UTG. 4

Squeaking noise in steering column assembly

Saab 900 M1994-

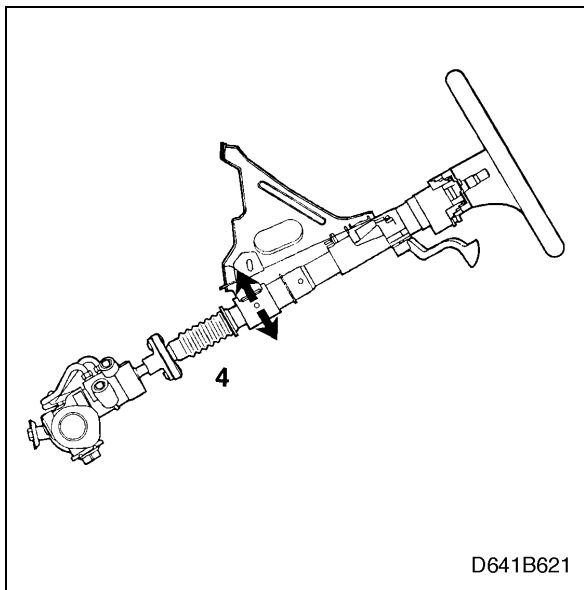
If the steering column assembly is mounted slightly askew, squeaking or creaking sounds may occur when the steering wheel is turned. This is due to clamping forces arising between the steering column assembly and the steering column, which subject the felt bearing (4) to a concentrated load. This can also give rise to stiff steering wheel adjustment or heavy steering.

In the event of customer complaints, the following steps can be taken to minimize the clamping forces:
