SERVICE INFORMATION

Bulletin Nbr: 641-2060

Cold draught from steering wheel

Saab 9-3 model year 98-

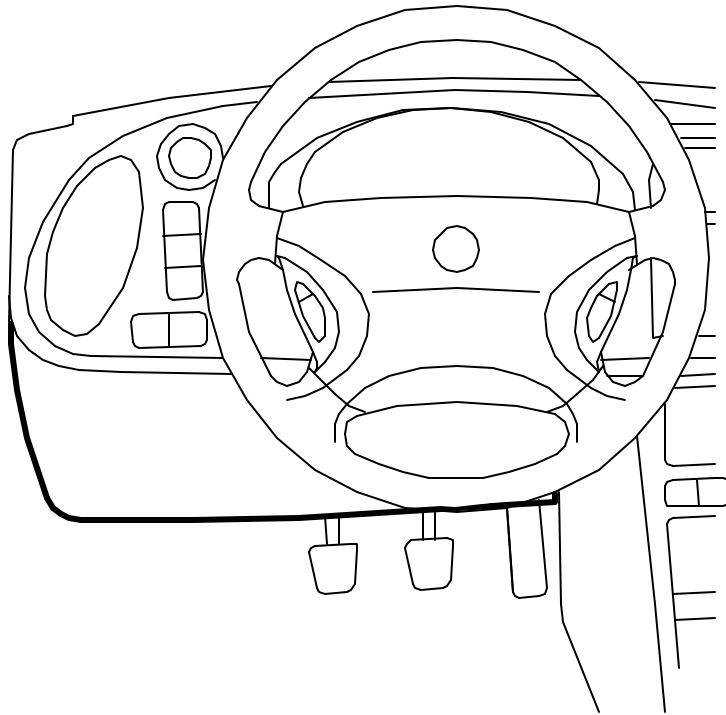
D641B625

After the car has been standing in a cold environment for a time, the airbag module in the steering wheel cools down. This causes a cold draught around the steering wheel, making the driver's hands and knees cold despite the cabin temperature being satisfactory. The airbag module has a large mass and takes a long time to warm up.

For customers that are affected, a sealing strip can be fitted to the airbag module that will reduce the risk of cold draughts.
