SERVICE INFORMATION

Bulletin Nbr: 811-1950

Replacing connecting tab on electrically heated rear window

Saab 9-3 CV

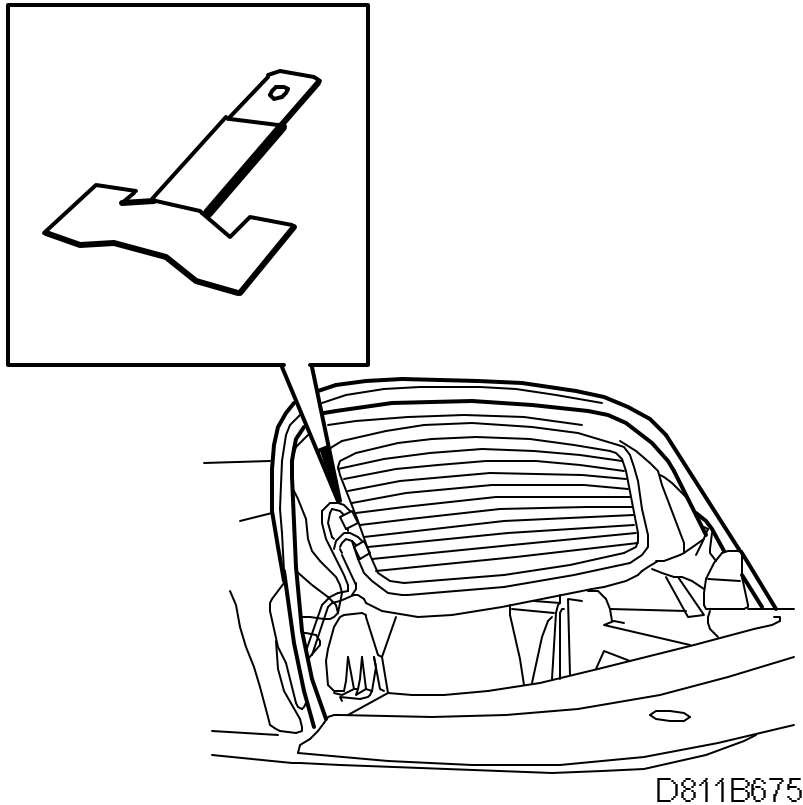
D811B675

Previously, when the connecting tab on the electrically heated rear window had come loose, it was necessary to replace the entire rear window. It is now possible to fit a new connecting tab instead by using conductive adhesive.
