**SERVICE INFORMATION**

Bulletin Nbr: 811-1989  
Date:.....December 1998  
Market: all

**The soft top does not open.**

Saab 9-3 CV M98 up to and incl. chassis no. W7054661 respective X7002303.

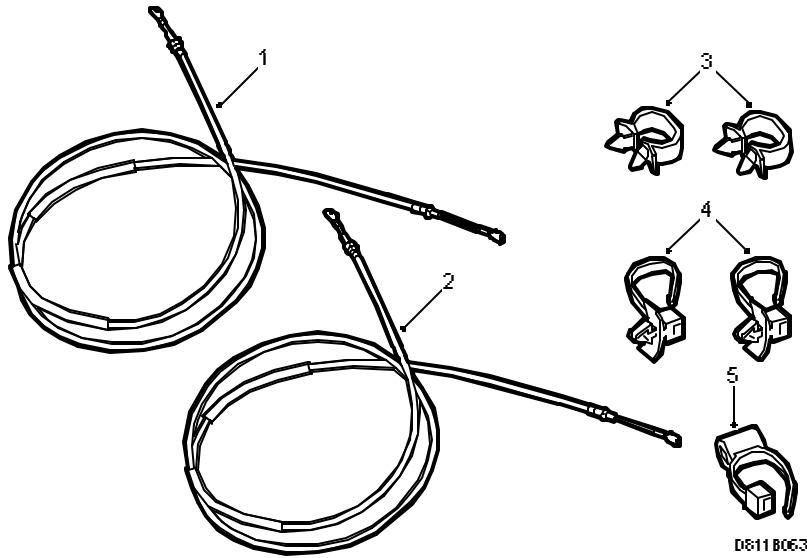
On certain cars, the soft top latch does not open fast enough or fully when the soft top is to be opened. This may result in the soft top getting stuck, thus breaking off the lock pin in the drive mechanism for the soft top cover.

The reason for the locks not opening may be depend on the cables to the lock for the soft top cover. These may have excessive internal friction or they may be deformed.

The problem is rectified by changing to a new, stronger and more flexible cables. The friction is thus decreased.

In addition, the mounting of the cables to the chassis is also changed.

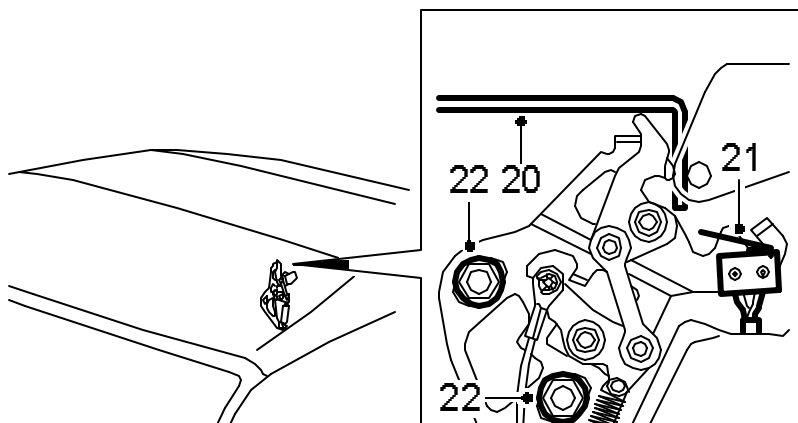
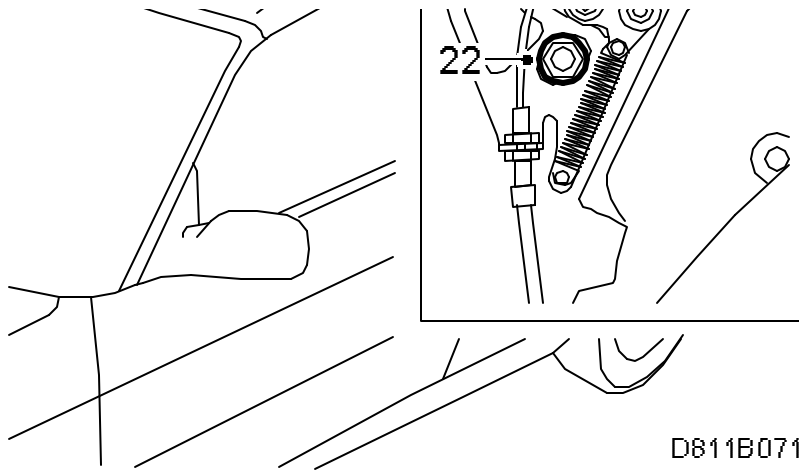
This adjustment is very important since the lock fitting can hook onto the lock which means that the lock pin in the soft top cover drive mechanism can break.

- 20. Raise the soft top cover so much that special tool 82 93 177 can be fitted as shown in the illustration.
- 21. Check that the soft top cover lock fitting enters the lock easily without touching the tool. Listen for a "clicking" sound when the microswitch is activated. If the lock fitting touches the lock, the lock must be adjusted forward in the car.
- 22. Adjustment:
  - Loosen the two nuts that hold the lock and press the lock forward. Tighten the nuts.
  - Return to step 20 and check the adjustment.
  - When closing, the soft top cover may "bang" in the locks. In this case, adjust the locks down so that the seals contact the the soft top cover.
