SERVICE INFORMATION

Bulletin Nbr: 811-2091
Date:.....Oktober 1999
Market: all

Rattling from inside the first bow and latch handle difficult to operate

Saab 9-3 Convertible up to and including VIN X7024103.

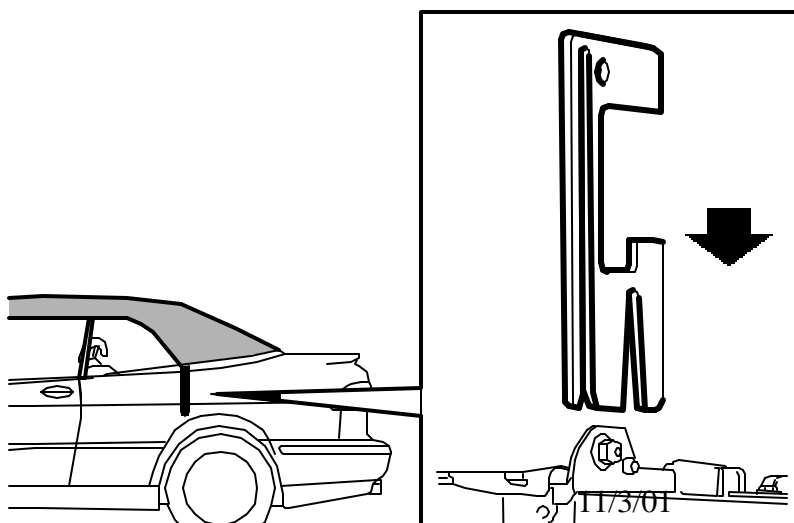
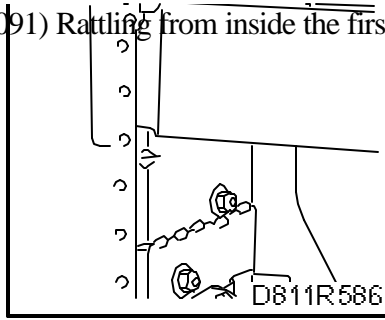
If the sound has not ceased, "Procedure 2" must also be carried out.

1. Follow the instructions in WIS, "Convertible 9-3", "Adjustment/replacement", "Adjusting the soft top".
2. Follow the instructions carefully and ensure that the measurements between the special tool and the first bow are correct.
3. Add shims to the right and left-hand sides if necessary, part no. 48 52 836.
4. Check that the soft top is not too far from the inner windshield (windscreen) frame.
5. After adjusting, perform another road test on an uneven surface and make sure the rattling has ceased.
