SERVICE INFORMATION

Bulletin Nbr: 811-2092

Noise from fifth bow lock mechanism

Saab 9-3 Convertible M98-M99 up to and incl. chassis no. X7055939

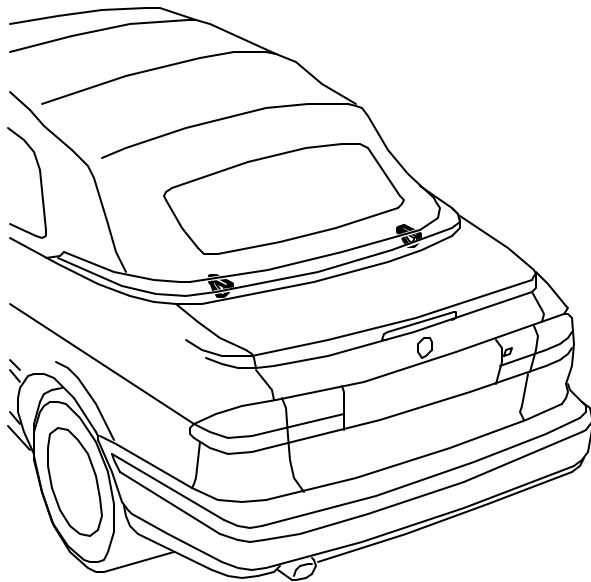
D8118091

On certain cars, noise can be heard from the fifth bow lock mechanism. The noise is caused when the lock engages or unlocks due to the lock fitting pushing on the lock mechanism. The following should be performed in case of customer complaints.
