**SERVICE INFORMATION**

Bulletin Nbr: 811-2092

**Noise from fifth bow lock mechanism**

Saab 9-3 Convertible M98-M99 up to and incl. chassis no. X7055939

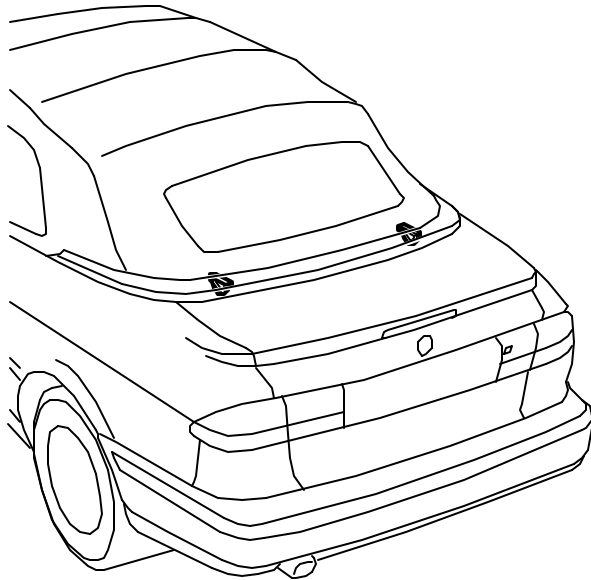
D8118091

On certain cars, noise can be heard from the fifth bow lock mechanism. The noise is caused when the lock engages or unlocks due to the lock fitting pushing on the lock mechanism. The following should be performed in case of customer complaints.
