**SERVICE INFORMATION**

Bulletin Nbr: 811-2100

**Noise from the door window glide rollers**

All Saab 9-3 Convertible M98 - M99 up to and incl. chassis no. X7057279.

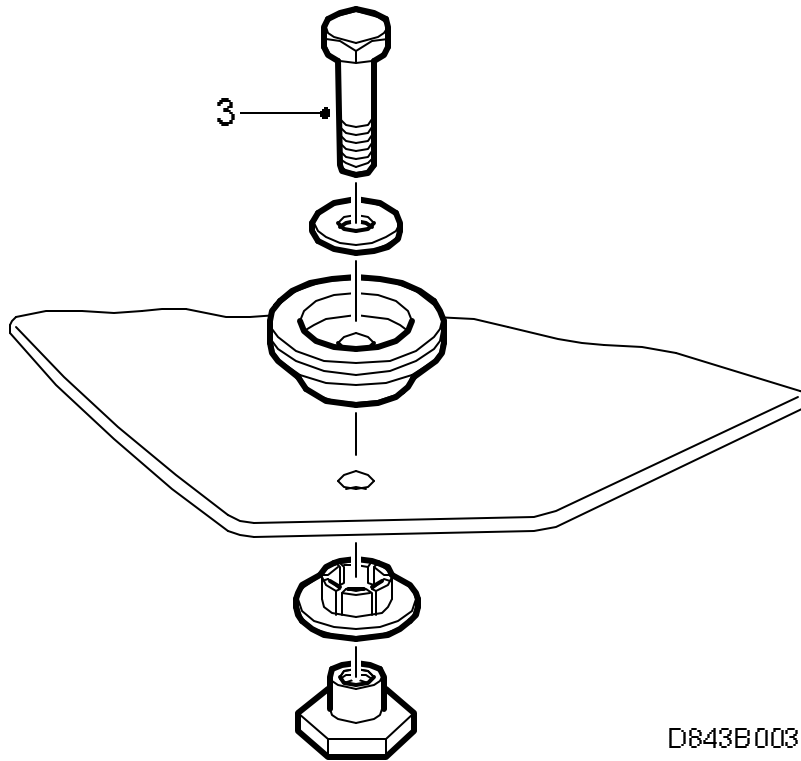
D843B003

On certain cars, the friction in the glide rollers can cause high-frequency creaking noise. In case of customer complaints, change the glide rollers to new rollers with the following part number.

2. Lay the window glass on a soft and level surface.
3. Remove the glide rollers. Loosen the screw (hold the nut on the rear of the window). Remove the glide roller.
4. Fit the new glide rollers part no. 51 13 436. Tighten the screws.

**Tightening torque : 9 Nm (6.7 lbf ft)**
