**SERVICE INFORMATION**

Bulletin Nbr: 811-2236

**Soft top cannot be operated**

Saab 9-3 CV M98 - M00 up to and including VIN Y7000913.

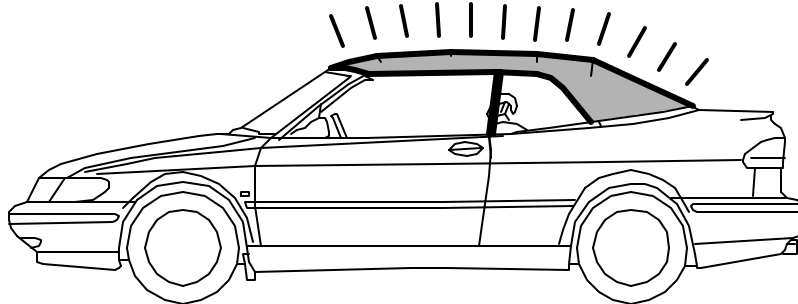
D811B183

The microswitches for the soft top cover latches can cause functional disorders and therefore have been replaced in production with microswitches of higher quality.

The soft top cannot be operated or it stops in mid-operation. SID displays the message CHECK SOFT TOP COVER and the following diagnostic trouble codes may be generated: B2025, B2026, B2030, B2031.

51 84 403 Microswitch
