SERVICE INFORMATION

Number: 831-1823

Rear doors, difficult to open from outside

Saab 900 5D, M94 - up to and including VIN W2004634.

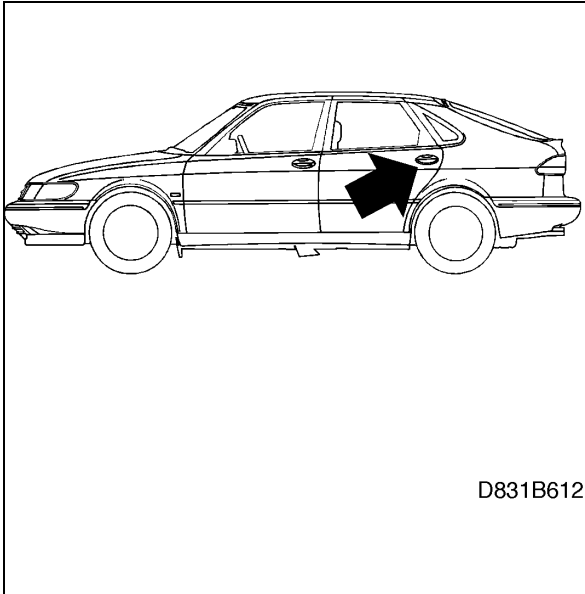
After a period of use, the rear doors may gradually become more difficult to open from outside. The problem occurs especially in warm climates.

The cause of this problem is that the thread in the adjusting nut to the exterior door handle loses its grip on the pull bar between the handle and the lock.

Rectify after customer complaint.
