SERVICE INFORMATION

Bulletin Nbr: 831-2109
Date:.....March 1999
Market: US, CA

Door weather seal fits poorly at top of B-pillar

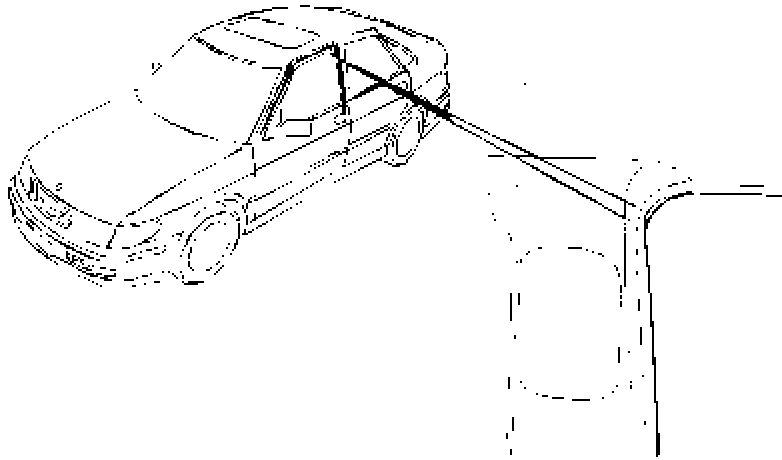
D831B620

The top rear corner of the door weather seal may fit poorly on certain cars. The lip on the door seal may not fit the radius on the B-pillar trim, which can give rise to a gap of up to 15 mm in the lip. The following measures should be taken after customer complaint.
