**SERVICE INFORMATION**

Bulletin Nbr: 841-1577 ed. 3

**Noise from the upper part of the windscreen**

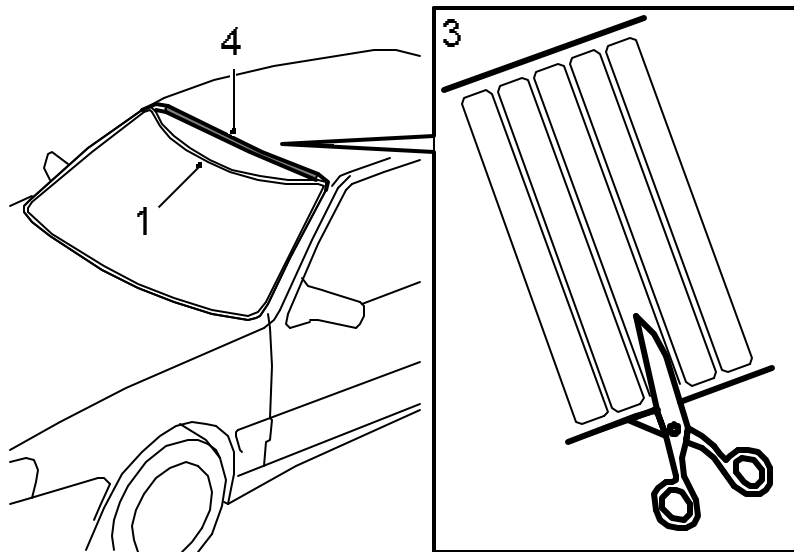
D843B625

On certain Saab 9-3, 900 and 9000 model cars a whistling noise can come from the top centre of the windscreen. The noise is especially apparent in hot weather and at high speeds.

In the case of customer complaint, the noise can be eliminated by fastening double-sided tape between the upper part of the windscreen trim and the roof panel.

1. Lift the trim from the upper part of the windscreen.
2. Clean the edge of the roof panel and the trim on its contact surface against the panel with Teroson cleaner FL or similar.
3. Divide the tape while it is still on the sheet, see illustration.
4. Centre the first piece of tape in the middle. Continue to apply two pieces of tape on each side and close to the middle one.
5. Refit the trim.
