SERVICE INFORMATION	
Bulletin Nbr:	844-1784
Date:SEPTEMBER 1997
Market:	ALL

Internal Front Door Window Seal is Coming Loose

Saab 900, 3-door (3D) and Convertible (CV)

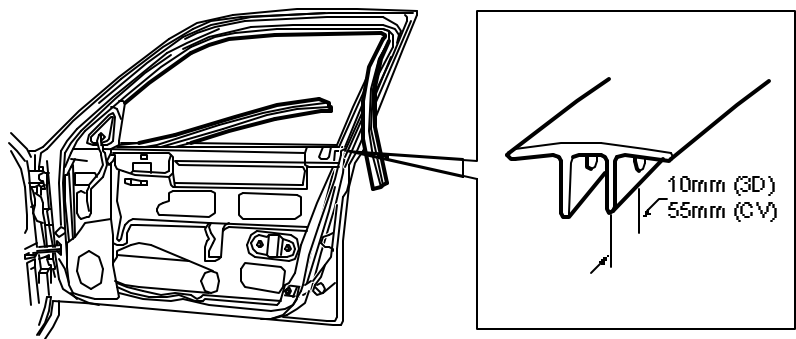
D843B001

The internal window seal on some cars can lift up a few mm at the rear edge. Follow the directions below to rectify this complaint.

Protect the window from drilling damage by putting a putty knife (or something similar) between the internal window seal and the window.

3. Drill a 2 mm hole approximately 10 mm (on 3-door) or approximately 55 mm (on Convertible) from the rear of the internal window seal.

Drill through both seal and flange.

4. Secure the seal with a screw, part number 79 75 535.
5. Refit the door panel.
