SERVICE INFORMATION
Bulletin Nbr: 844-1784 UTG. 2
Date:.....NOVEMBER 1998
Market: ALL

Internal Front Door Window Seal is Coming Loose

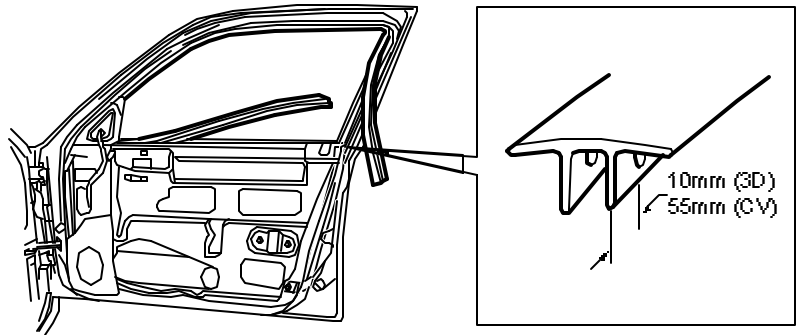
D843B001

The internal window seal on some cars can lift up a few mm at the rear edge. Follow the directions below to rectify this complaint.

Protect the window from drilling damage by putting a putty knife (or something similar) between the internal window seal and the window.

3. Drill a 2 mm hole approximately 10 mm (on 3-door) or approximately 55 mm (on Convertible) from the rear of the internal window seal.

Drill through both seal and flange.

4. Secure the seal with a screw, part number 79 75 535.
5. Refit the door panel.
