SERVICE INFORMATION

Number: 854-1671

Condensation in air ducts

Saab 900 Cabriolet.

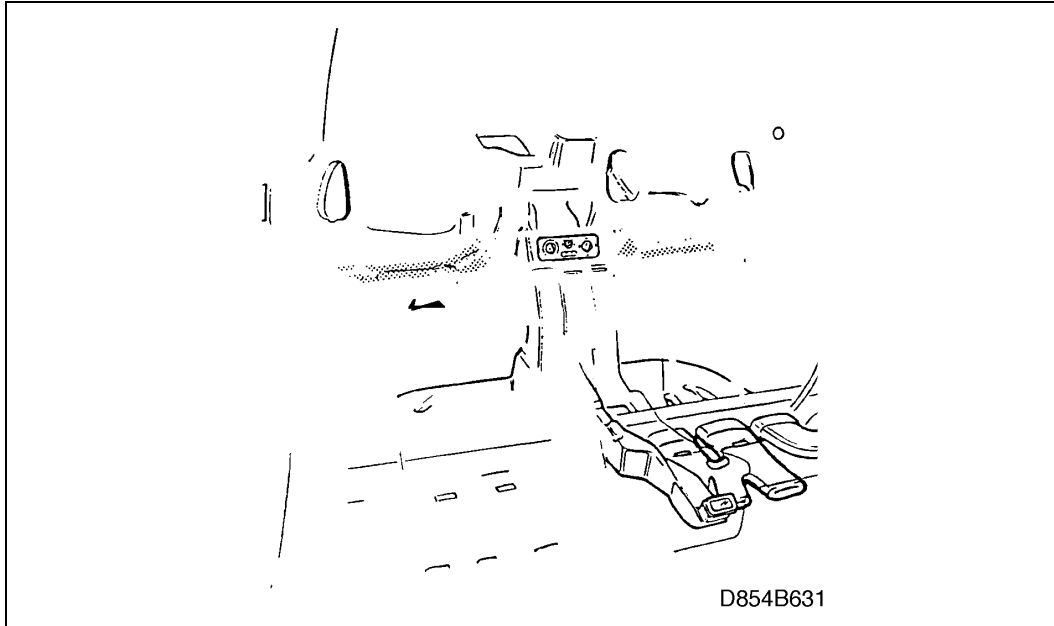
In hot and damp climates and under certain driving conditions, water may drip from the air ducts onto the floor under the dashboard. The cause of this is the transport of dehumidified air from the evaporator which condenses on the colder surfaces of the air duct.
