MODIFICATION INSTRUCTION	
Bulletin Nbr:	890-2264
Date:Juni 2000
Market:	US,CA

Damage to paintwork on sill under rear left door

Customer satisfaction campaign 118 05

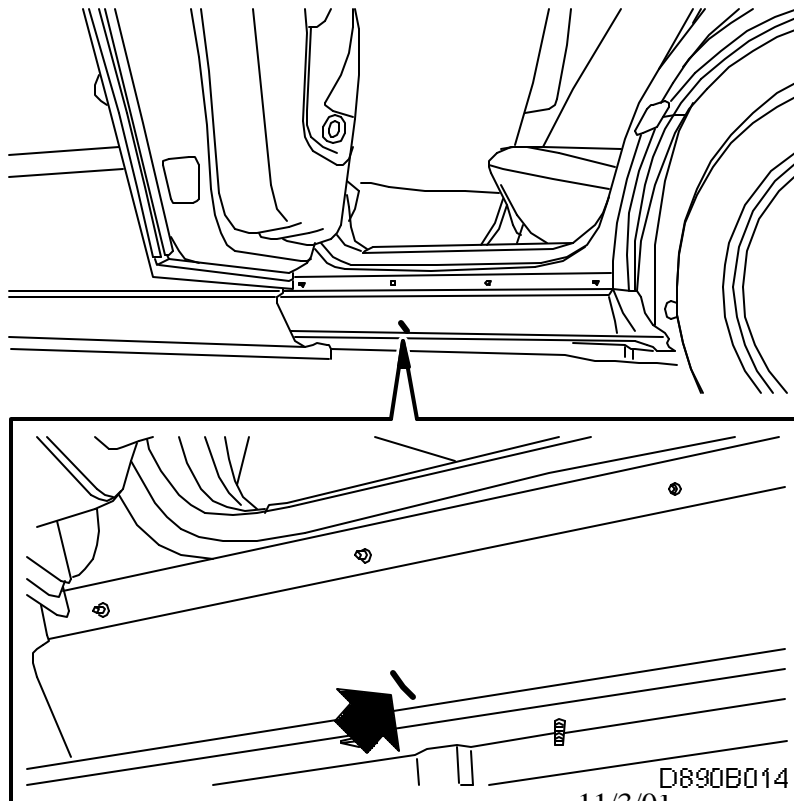
The sill under the rear left door has been scratched in production. The scratch is 2 cm long and is located under the third weld screw from the bottom.

Check box A2 on the modification identity plate before proceeding. Continue as follows if the box is not marked.

1. Remove the left-hand scuff plate, see WIS - Exterior - Adjustment/replacement - Outer scuff plate 5D and Outer scuff plate sports package/Aero 5D.
2. Thoroughly wipe the damaged area with cleaning agent, Cleaner Teroson FL T875.
3. If the damage has penetrated down to the ED layer or the metal, Standox etching primer must be applied to the damaged area. Allow the primer to air-dry for 10 minutes.
4. Apply the base paint to the damaged area and allow it to air-dry for 10 minutes.
5. Apply clear enamel to metallic base paint. Do not apply clear enamel to solid paints.
6. Fit the scuff plate, see WIS - Exterior - Adjustment/replacement - Outer scuff plate 5D and Outer scuff plate sports package/Aero 5D.

The paint does not need to dry before fitting the scuff plate.
