TECHNICAL NEWS

Bulletin Nbr: 98-09

Blocked hose on EVAP canister**Cars affected**

Saab 9-3 up to and including VIN W2061707, X2005838.

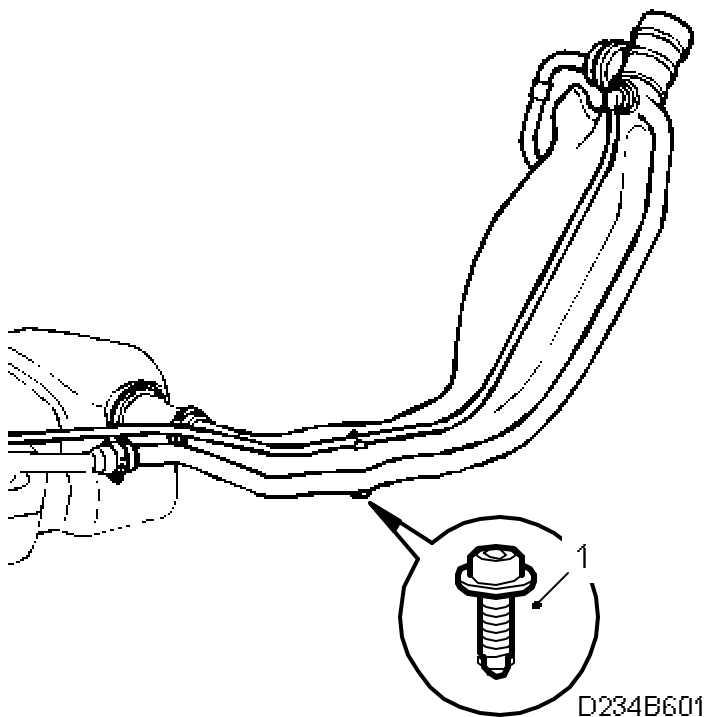
The hose on the EVAP canister on a small number of cars may have been bent due to incorrect assembly on the production line. This can block the system and cause a number of faults that can not primarily be traced to this cause, e.g.

- Engine stalls and can be restarted after a couple of hours.
- Loss of power.
- Vibration during acceleration.
- DTC P0172 displayed on the diagnostic tool.

- Incorrect fuel gauge reading.
- The fuel tank can be deformed so much that it can even be completely compressed after a time. Check the pump and fuel sensor.

If a car displays one or any of the problems described above, check the hoses on the EVAP canister and adjust their positions if necessary. See illustration.
