Subject: TRIONIC Flashing Lamp Fault Codes

Application: 1993 9000 Models

CATEGORY		Engine	
SECTION	2	PAGE	21
ISSUE	11/92-0268	CODE	200

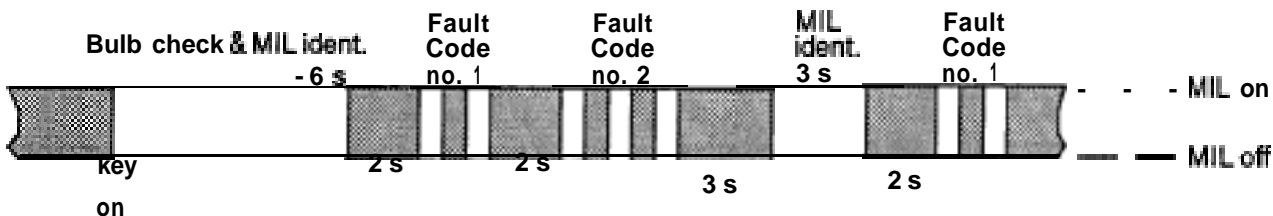
Figure 1. Flashing Light Fault Codes

2. In about six seconds the Malfunction Indicator Lamp (CHECK ENGINE lamp) will go out for about 2 seconds. It will then begin flashing the first fault code.
3. The codes consist of a number of flashes, each having a duration of 0.4 seconds. The Malfunction Indicator Lamp (CHECK ENGINE lamp) will go out for two seconds between each new series of flashing codes (if there is more than one fault).
4. After the last series of codes the lamp will go out for 3 seconds then it lights up again for another three seconds, following which the flashing codes will be repeated. The fault codes will be repeated in this way as many times as desired.
