**Subject: Cold Weather Starting Problems****Application: 1988-89 900 Models with EZK Ignition**

CATEGORY	
Engine	
SECTION 3	PAGE 6
ISSUE 03/91-0093	CODE 271

Supersedes S.I. 01/90-1208

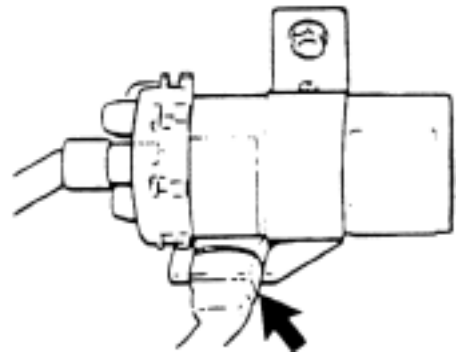
1988-89 900 models with EZK ignition system (B2021 engine) utilize a power stage integrated with the ignition coil. The ground wire for this power stage has a relatively long travel resulting in the possibility of enough ground circuit resistance to affect cold weather engine starting.

Figure 1. 4-pin connector at the power stage.

To shorten this ground path, a procedure has been developed to install a new ground wire from the power stage directly to the right-hand inner fender. This procedure also includes replacement of the hard plastic cover over the coil with a rubber boot for improved moisture protection.

1. Disconnect the 4-pin connector from the power stage (see Figure 1) and peel back the connector's protective boot.
2. Push pin No. 2 (wire 648, black) back out of the connector and cut off the terminal. Tape this wire back to the harness.
3. Install the new ground wire from the kit through the sleeve of the boot and into pin 2 of the connector. Refit the boot over the connector.
4. Connect the 4-pin connector to the power stage.

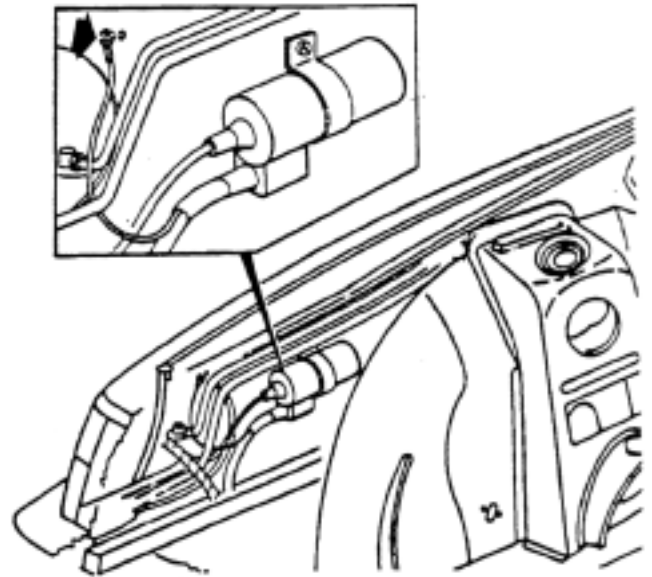
Figure 2. Drill a 3 mm hole in the **RH** inner fender.

5. Drill a 3 mm hole in the **RH** inner fender as shown in Figure 2.
6. Clean the **surface** around the hole to provide a good contact to ground.
7. Route the cable as shown and install the screw supplied with the kit through the ring terminal on the end of the ground wire.
8. Spray the screw and surrounding surfaces with a **rust** protection solution.
9. Remove the plastic cover from the coil and **with**-draw the secondary wire leading to the distributor. Clean the areas around the high and low tension terminals.
10. Insert the secondary wire into the rubber boot supplied with the kit and install the boot onto the coil.
