SERVICE INFORMATION

Number: 210-1714
Year: 1996
Month: DECEMBER
Market: ALL

Changed tightening torques for cylinder head bolts

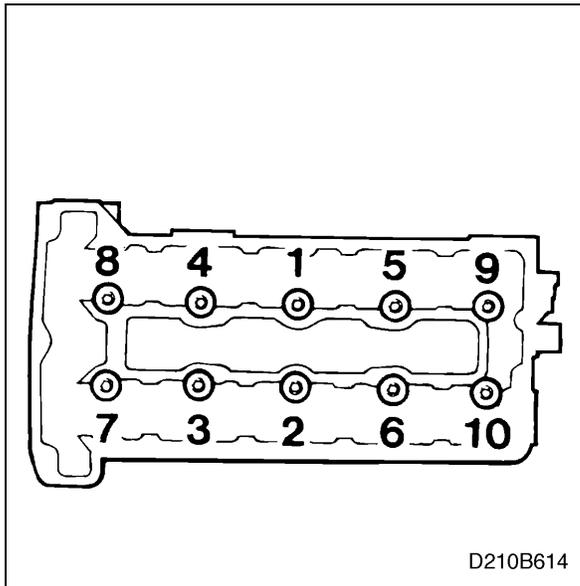
The tightening torques for the cylinder head bolts have been changed due to difficulties in getting the tightening torque to remain stable. The new tightening torques are as follows:

Tightening torques for the cylinder head bolts		
	Nm	lbf ft
Stage I	40	30
Stage II	60	44
Stage III	Tighten a further 90°
