SERVICE INSTRUCTION

Number: 641-2115

Cold downdraft from steering wheel

Saab 9-5 model year 98-

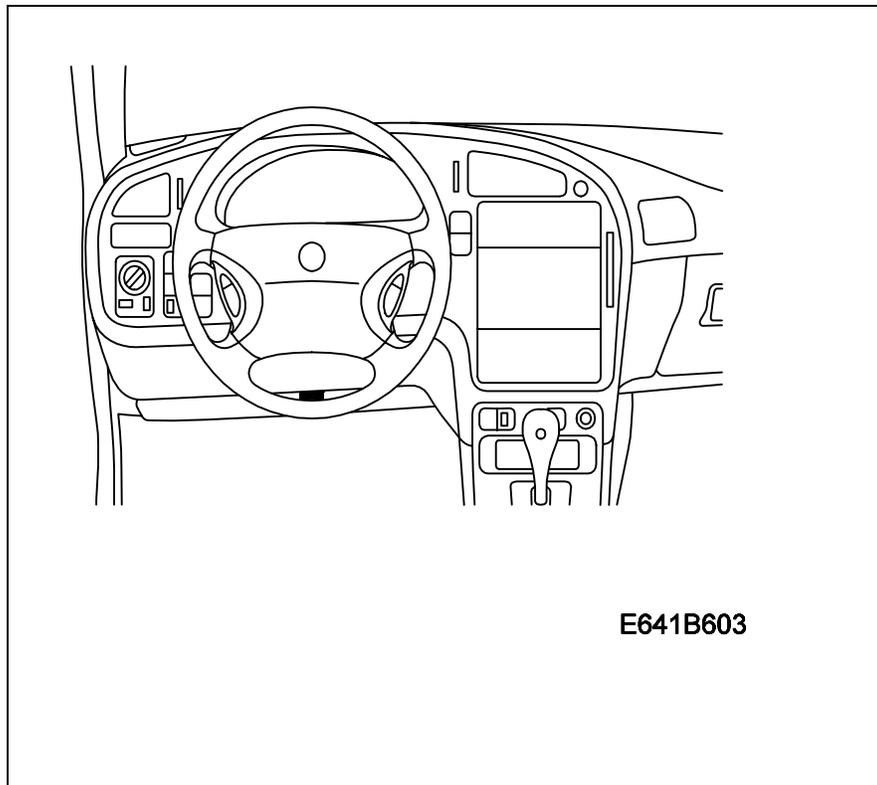
After standing in the cold for a while, the airbag module in the steering wheel will have become cold. This results in a cold downdraft, making the hands and the knees of the driver cold, despite the cabin temperature being normal. The air bag module is a large mass and requires a long time to warm up.

To address a customer complaint of this nature, a weatherstrip can be fitted on the airbag module to reduce the risk of downdraft.
