SERVICE INFORMATION

Bulletin Nbr: 811-1989
Date:.....December 1998
Market: all

The soft top does not open.

Saab 9-3 CV M98 up to and incl. chassis no. W7054661 respective X7002303.

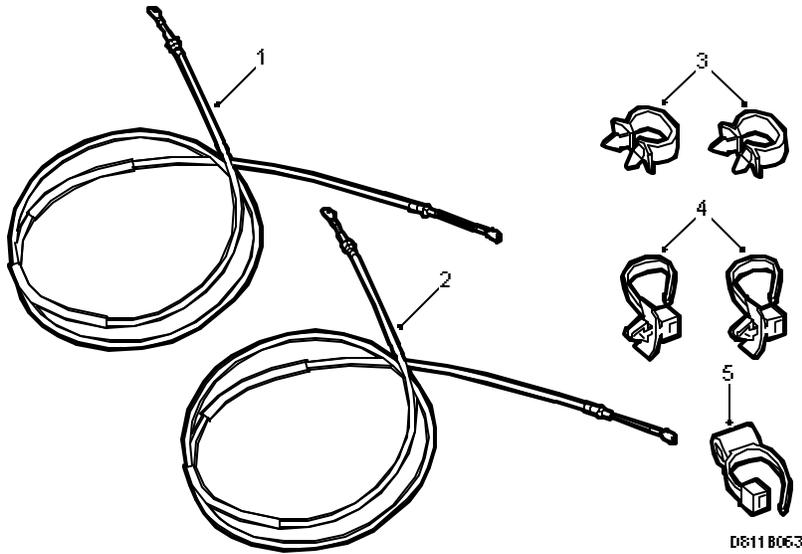
On certain cars, the soft top latch does not open fast enough or fully when the soft top is to be opened. This may result in the soft top getting stuck, thus breaking off the lock pin in the drive mechanism for the soft top cover.

The reason for the locks not opening may be depend on the cables to the lock for the soft top cover. These may have excessive internal friction or they may be deformed.

The problem is rectified by changing to a new, stronger and more flexible cables. The friction is thus decreased.

In addition, the mounting of the cables to the chassis is also changed.

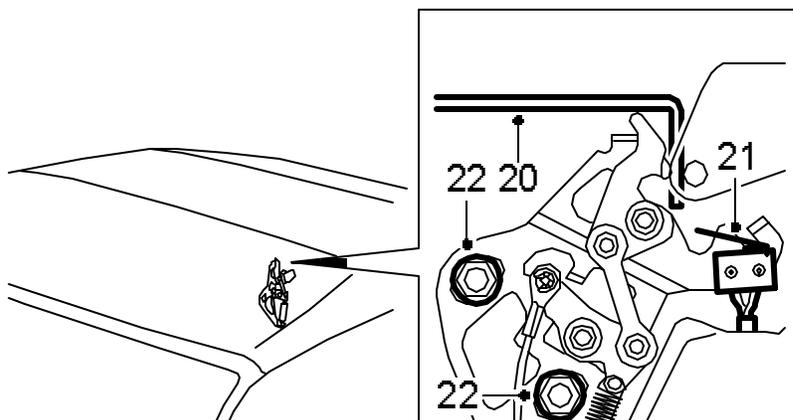
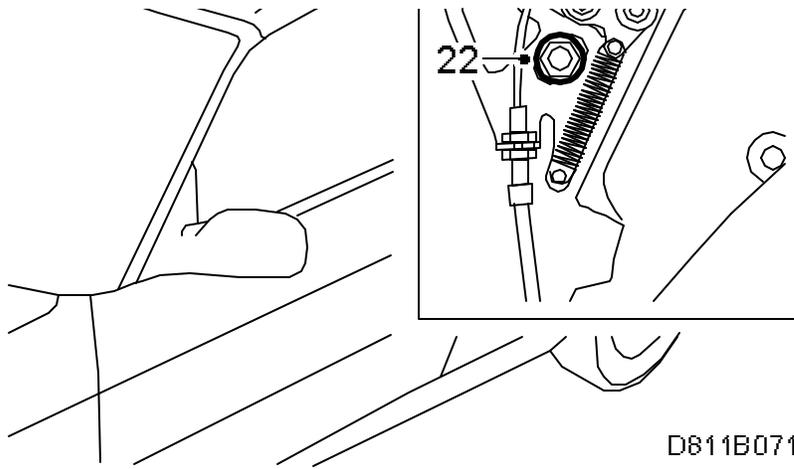
D811B071

This adjustment is very important since the lock fitting can hook onto the lock which means that the lock pin in the soft top cover drive mechanism can break.

- 20. Raise the soft top cover so much that special tool 82 93 177 can be fitted as shown in the illustration.
- 21. Check that the soft top cover lock fitting enters the lock easily without touching the tool. Listen for a "clicking" sound when the microswitch is activated. If the lock fitting touches the lock, the lock must be adjusted forward in the car.

Loosen the two nuts that hold the lock and press the lock forward. Tighten the nuts.
