SERVICE INFORMATION

Bulletin Nbr: 811-2100

Noise from the door window glide rollers

All Saab 9-3 Convertible M98 - M99 up to and incl. chassis no. X7057279.

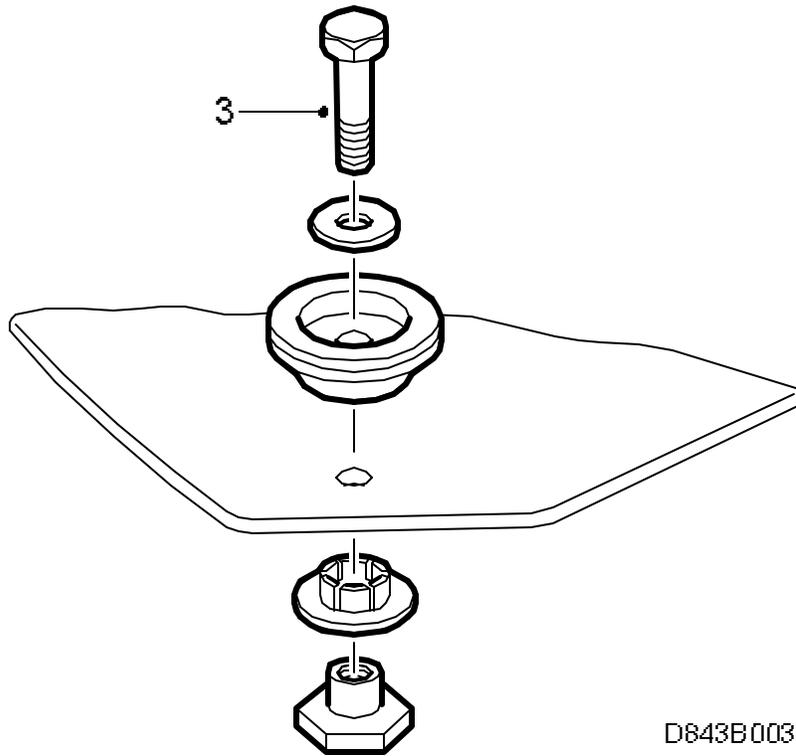
On certain cars, the friction in the glide rollers can cause high-frequency creaking noise. In case of customer complaints, change the glide rollers to new rollers with the following part number.

2. Lay the window glass on a soft and level surface.
3. Remove the glide rollers. Loosen the screw (hold the nut on the rear of the window). Remove the glide roller.
4. Fit the new glide rollers part no. 51 13 436. Tighten the screws.

Tightening torque : 9 Nm (6.7 lbf ft)

5. Remove the door window rear guide rail. See WIS "Convertible 9-3", section "Adjustment, replacement", "Door window rear guide rail".
6. **Wash off all lubricant from the inside of the guide rail.**

It is absolutely forbidden to use lubricant on the inside of the guide rail.
