<b>SERVICE INFORMATION</b>	
Bulletin Nbr:	811-2234
Date:	.....May 2000
Market:	all

**Noise from side window seals on Convertible**

All Saab 9-3 CV

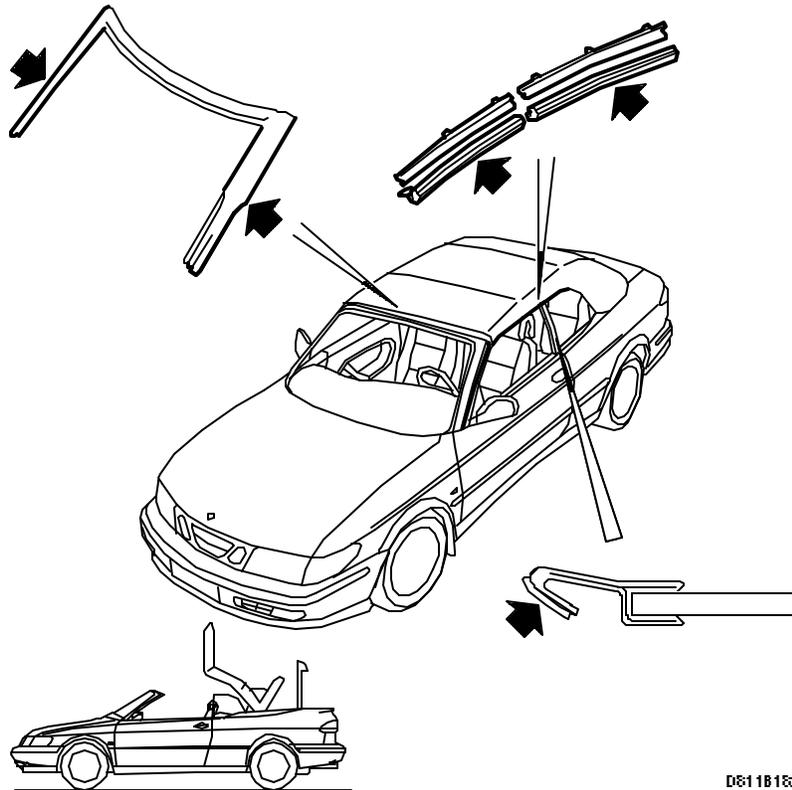
Vibration of the side windows causes slip varnish wear on the seals and impairs the noise suppressing qualities of the slip varnish.

Squeaking or ticking noise from side window seals.

1. Press the ROOF button to open the soft top about half way while the soft top cover is standing straight up. Place the soft top support, special tool (16) 82 93 144, so that the soft top will not fall once the hydraulic pressure has been released. The rear windows must be raised and the door windows lowered.
2. Apply lubricant to the surface of the sealing strips as illustrated.
