SERVICE INFORMATION

Bulletin Nbr: 854-2233

Water on floor

All Saab 9-3 equipped with A/C or ACC.

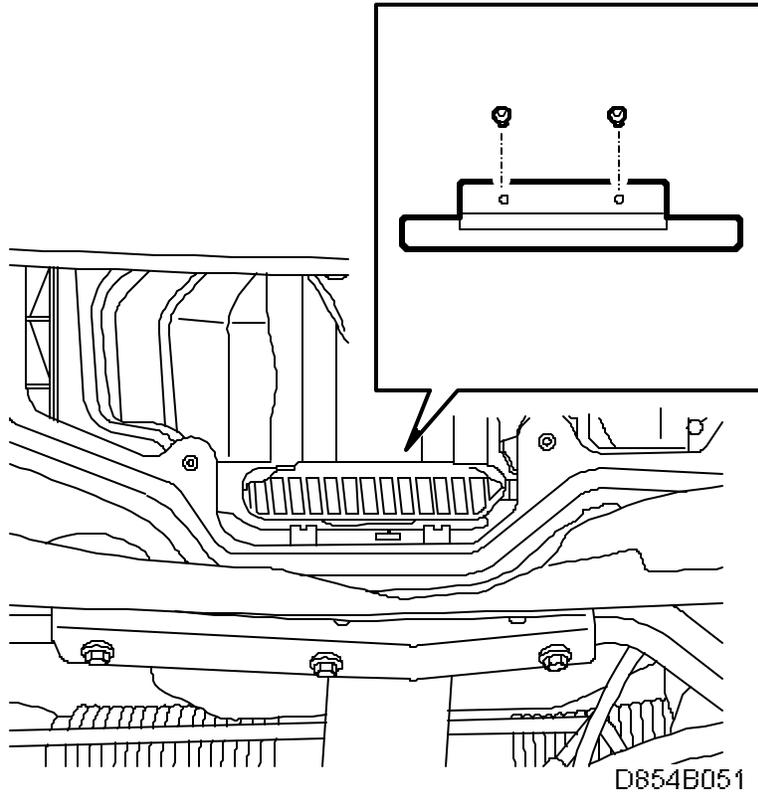
In certain hot weather conditions with high humidity, it is possible that the climate system does not manage to dehumidify all the damp air. This can result in water dropping onto the floor from the lower air vents.

Water on floor. Water dropping onto the floor from the lower air vents.

53 32 358 Air deflector including screws (CA: 30586511)
