TECHNICAL NEWS

Bulletin Nbr: 98-11-475

Noise from outboard drive shaft CV joints

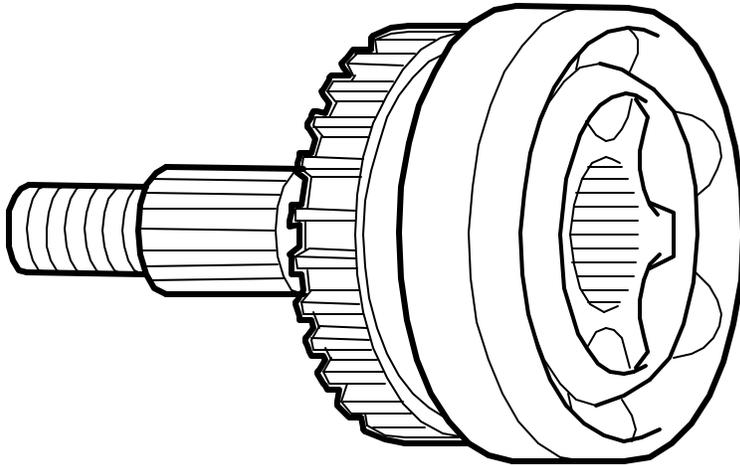
D475B602

On new cars, noise from the outboard driveshaft CV joints can be heard when the wheels are turned to full lock at the same time as the accelerator is depressed.

This is because the grease in the joints has not had time to be properly distributed.

In the case of a complaint about the above, inform the customer that the noise will disappear when the car has been driven normally for about 100-150 km (65-100 miles).
