SERVICE INSTRUCTION

Number: 113-2084

Changes to Saab Original Service Programmes

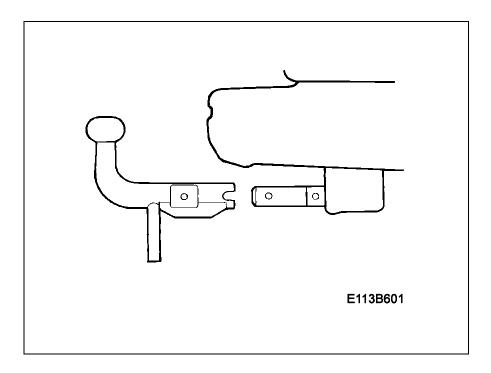
When fitting the towbar attachment, there is a danger of it not locking correctly to the coupling pin if the pin is dirty or inadequately greased.

Clean the coupling pin as necessary. Grease the coupling pin at every service interval with Molycote 33. Check that the towball unit is easy to fit and remove and that it locks securely.
