| SERVICE INFORMATION Bulletin Nbr: 381-1934 Date:.....MARCH 1998 Market: ALL |

SID message "Time for Service"

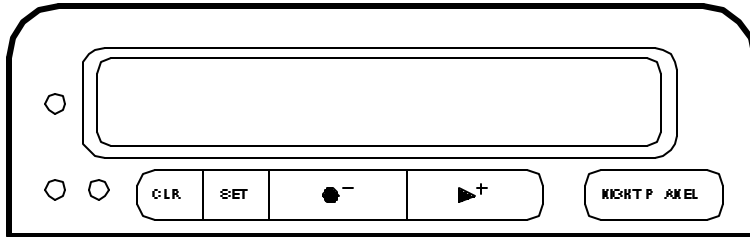
D238D064

New software in the SID necessitates a different way of resetting the message "TIME FOR SERVICE" with the SID CLEAR button.

To reset the "TIME FOR SERVICE" message on the SID (without using Tech 2), follow the instructions below:

1. Press the CLEAR button once.

-
2. Press the CLEAR button again and hold it down for at least 8 seconds.

The SID will sound an acoustic signal and shortly afterwards another one. After the second signal, "SERVICE" will start flashing.

-
-
3. Restart to check that the message has been reset.
