### SERVICE INFORMATION

Bulletin Nbr: 853-1751 Date:.....MAJ 1997

Spacer washers as spare part for side consoles, seat-belt member

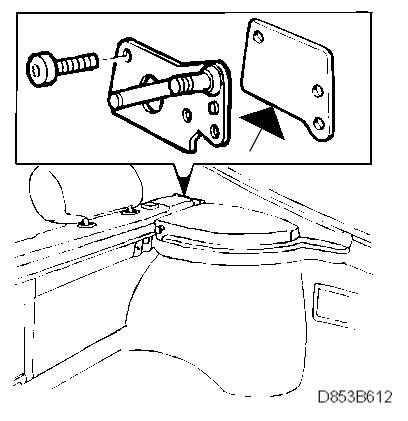
The body width varies between the 3- and 5-door cars. In order to avoid that the side console and the seat-belt member make contact during assembly, spacer washers in the materials kit as a spare part must not be used on 5 door cars.

When replacing the side console on 5-door cars, first check if there is a spacer washer behind the side console.

• If the car lacks a spacer washer, the spacer washer included in the materials kit must not be fitted.

• If there is a spacer washer, it should be refit.
