TECHNICAL NEWS

Bulletin Nbr: 99-02-855a

Locking mechanism, tailgate

Saab 9-3 M98 - M99 up to and including VIN X2053929.

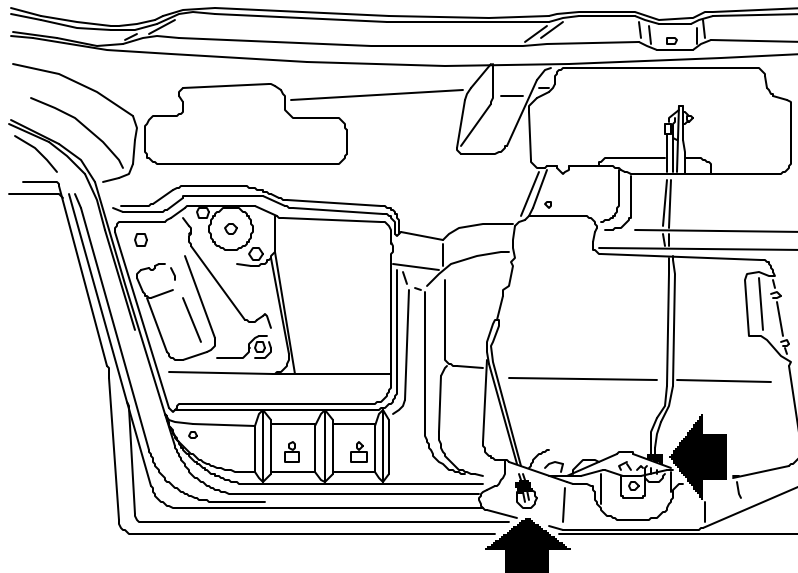
D855B603

The tailgate on certain cars has occasionally been difficult to open due to a few defective clips. If a clip falls out when the tailgate is locked, it will remain locked. If the clip falls out when the tailgate is open, it can not be locked again.

Replace the black clip with the blue one. Remove the interior handle from the tailgate trim, remove four black clips, bend out the trim carefully, grasp the lock arm and press it down. This will unlock the tailgate. Go to the back of the car and open the tailgate, remove the trim and replace the clip. See illustration. Fit the tailgate trim and the interior handle.

If the clip securing the link arm to the lock cylinder is broken, it may be necessary to remove

the locking mechanism in order to replace the clip.
