TECHNICAL NEWS

Bulletin Nbr: 99-08-731b

Transport support

Saab 9-3 Viggen.

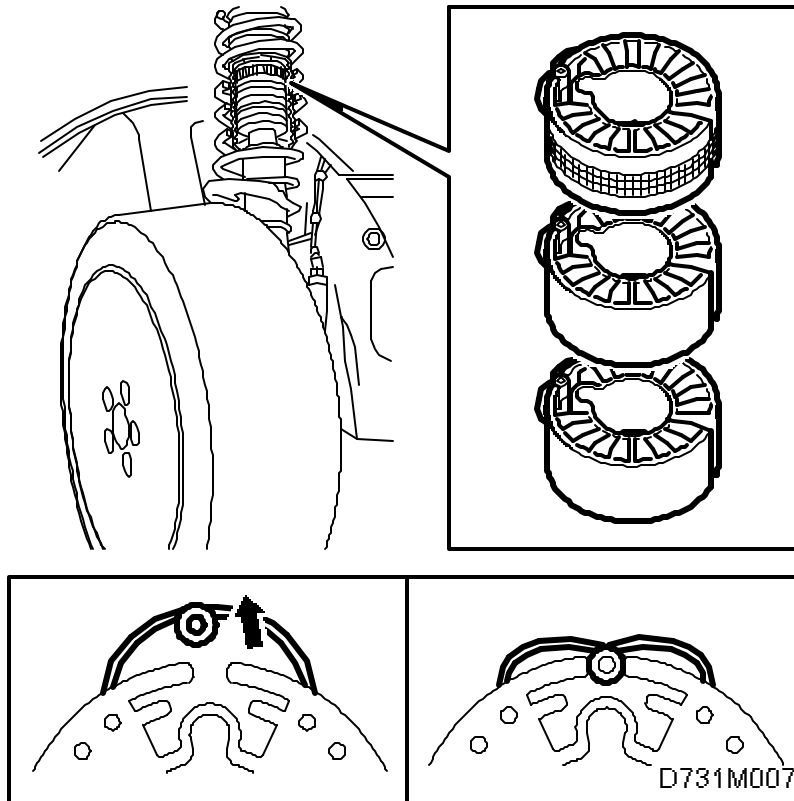
Due to a lower chassis in combination with a new front spoiler, a transport support has been fitted under the rubber protection on the damper piston. There are three supports on each side. The transport support is removed in connection with the pre-delivery service.

The upper transport support must be wrapped with Scotch 3M Tape, type 8981 (approx. 0.4 m per side) for safety reasons.

It is important that the transport support and warning plate are saved so that they can be

reused if the car is to be transported again.
