## TECHNICAL NEWS

**Number:** 98-12-843

### Door mirror casing comes loose

Saab 9-5 up to and including VIN W3077258 (M98) and X3001490 (M99) respectively

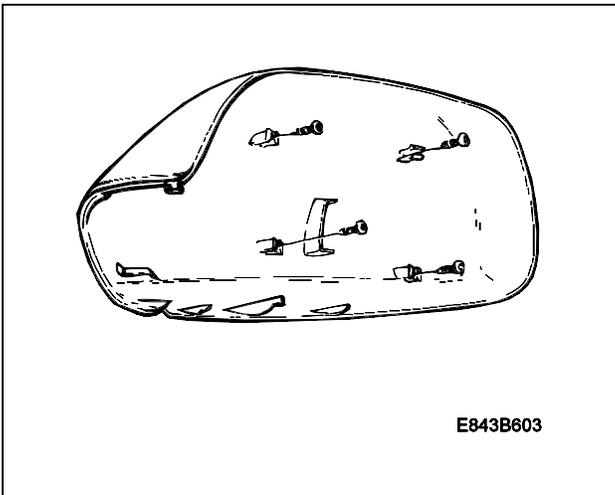
Door mirror casing comes loose.

- 1 Remove the mirror glass.
- 2 Make sure the glass was not damaged during removal.
- 3 Open the three clips just enough to fit the screws (part no. 79 75 535), which will reinforce the casing mounting. See illustration.
- 4 Make sure there are no depressions in the mirror casing. If this is the case, loosen the screws 1-2 turns.
- 5 Make sure the rubber bellows for the mirror motor are in place.
- 6 Fit the glass with the motor in its centre position. The glass must not be loose. Make sure the glass is located correctly.
- 7 Check that the glass can be adjusted to all end positions.
