## SERVICE INSTRUCTION

**Number:** 843-1953

### Juddering side windows (unsmooth operation)

Saab 9-5 up to and including VIN

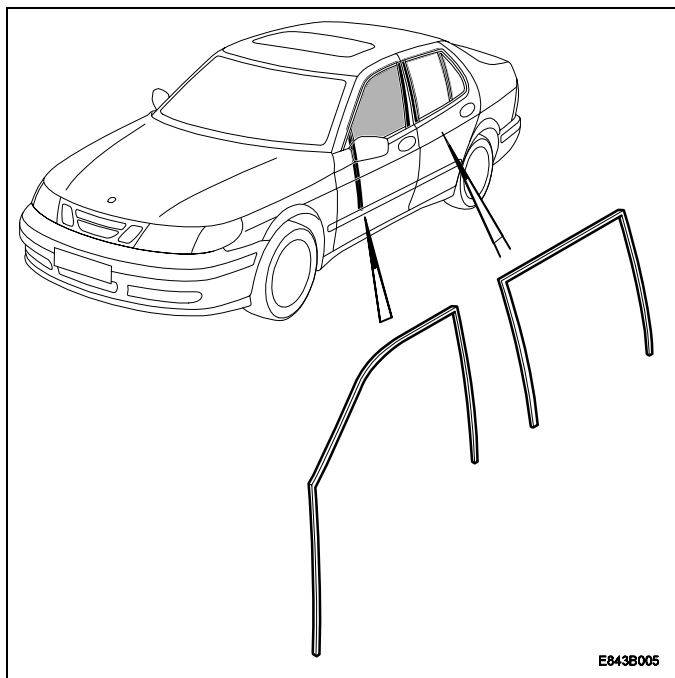
The side windows can occasionally judder when being raise and lowered.

This is because the pop rivets behind the window moulding are too long. The resulting friction between the moulding and glass is too great. In addition, the window mounting require adjustment.

To resolve a customer complaint, the following procedure can be performed.
