MODIFICATION INSTRUCTION

Bulletin Nbr: 291-2217 utg. 2

Replacement of check valve and banjo screw to remedy blue smoke

Emissions-related campaign 10719

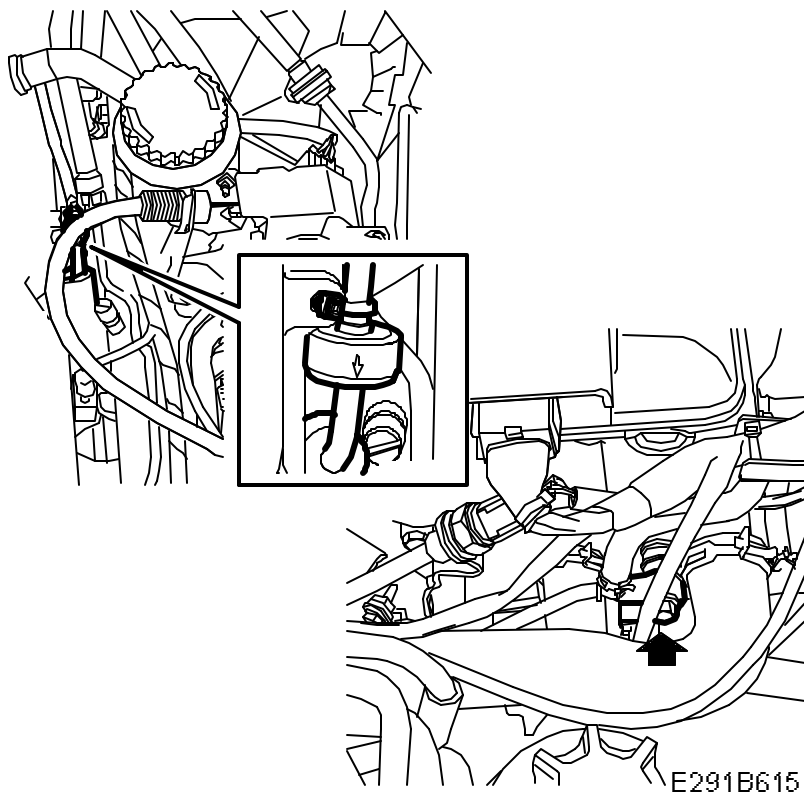
Some cars produce unwanted blue smoke. There are two possible reasons:

- The check valve for the crankcase ventilation can stick, which means that engine oil can be forced out into the exhaust pipe, resulting in blue smoke.
- The flow of coolant through the turbo unit may be reduced, which results in the temperature becoming so high that the engine oil crystallizes (builds carbon deposits) around the turbine-side bearing. Over time these deposits reduce the oil flow through the bearing, which means that engine oil is forced past the turbine shaft seal and out into the exhaust pipe, resulting in blue smoke.

This MI describes the procedure for preventing blue smoke and damage to the turbocharger.

-
6. Fasten the check valve to the camshaft cover using a cable tie.
 6. Make sure the ignition key is in OFF position.
 7. Remove the bolt attaching the turbocharger delivery pipe to the engine and the hose clip on the pipe attachment to the throttle body.
 8. Remove the turbocharger delivery pipe and move it to one side. Keep the O-ring.
 9. Turn the throttle disc to open position and clean inside the throttle body, especially around the throttle disc sealing surface. Use a lint-free cloth moistened with electronic cleaner (part no. 16 - 30 04 223).
 10. Lubricate the O-ring with acid-free petroleum jelly and fit the turbocharger delivery pipe to the throttle body.
 11. Fit the bolt attaching the turbocharger delivery pipe to the engine and the hose clip on the pipe attachment to the throttle body.
 12. Fit the engine cover.
