SERVICE INFORMATION

Bulletin Nbr: 811-2091
Date:.....Oktober 1999
Market: all

Rattling from inside the first bow and latch handle difficult to operate

Saab 9-3 Convertible up to and including VIN X7024103.

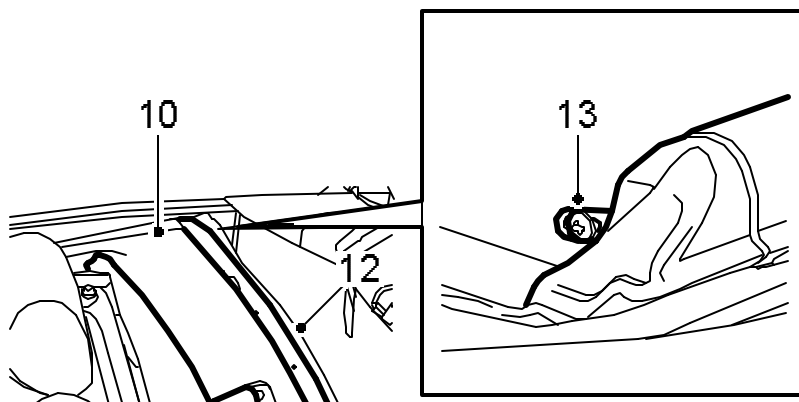
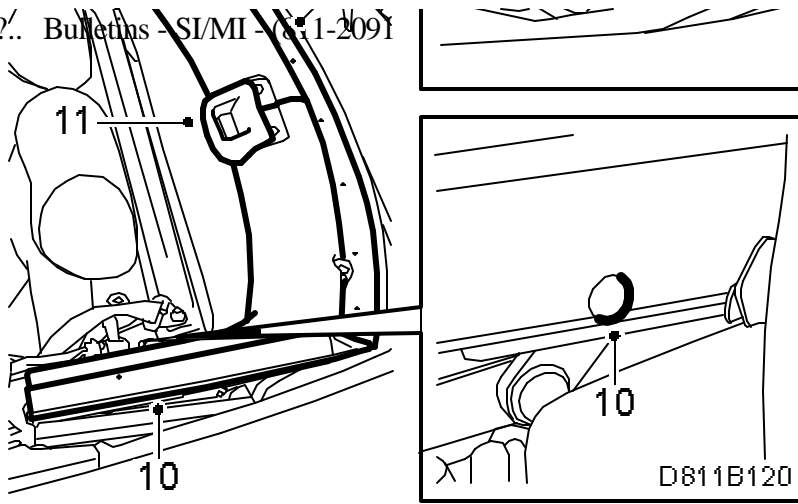
On certain cars, it is possible that a rattling noise can be heard from inside the first bow. The sound can be traced to the first bow latch and latch handle.

11. Apply grease, (16) 30 20 476, to the handle shanks and fit the handle. Remove the rag protecting the headlining.
12. Fit the retaining strip on the front of the first bow (9 screws), do not use the two long screws intended for the seal adjustment.

Take care not to damage the latch magnets.
